Technical Bulletin

U-Scan Upgrades for New \$5 Bill

SC-TECH-08:05 Issue 2

**Updating the U-Scan
CashCode Bill Acceptor to Accept the New \$5 Bill
Using ASM Update Method**

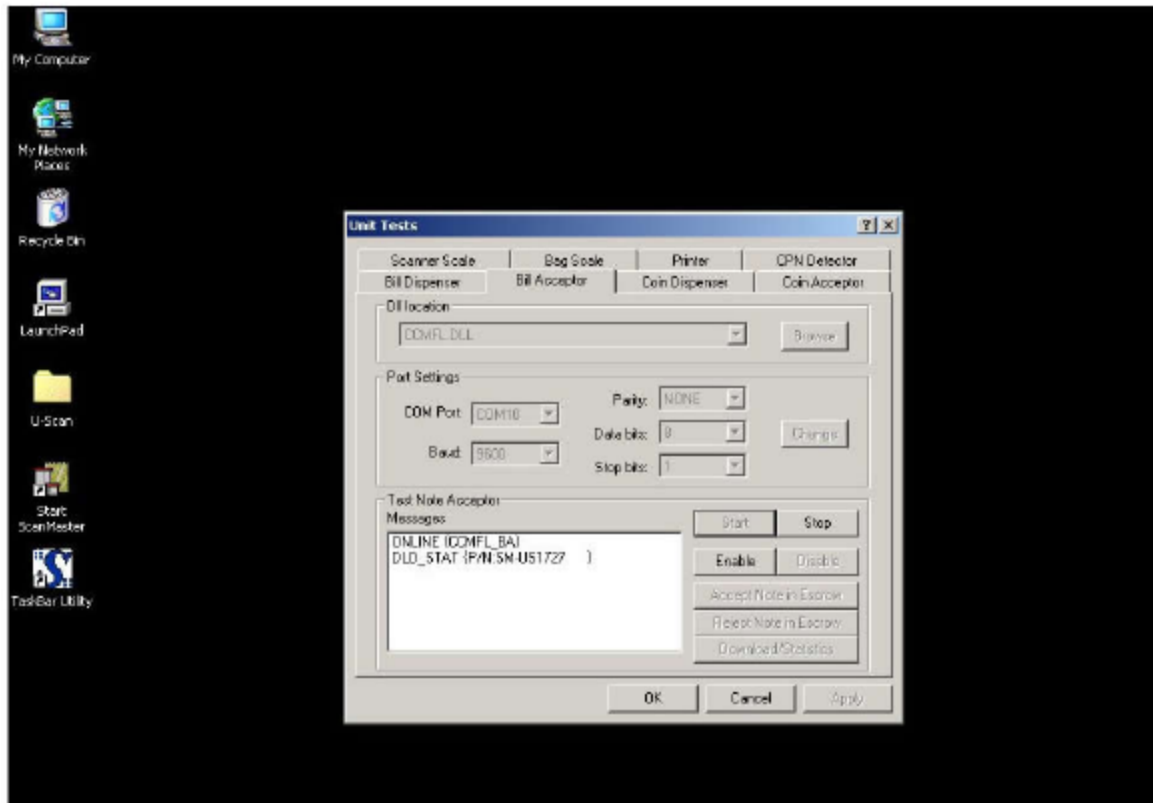
1. Stop the ROBOT (from Maintenance Mode)
2. Verify the Bill Acceptor is using the CCMFL_BA.dll and P/N is SM-US17XX from Device Tester. Select Bill Acceptor and press START

If you have something other than SM-US17XX displaying (you may see US1727, US1729, US1730, but it should be below US1732), contact Support.

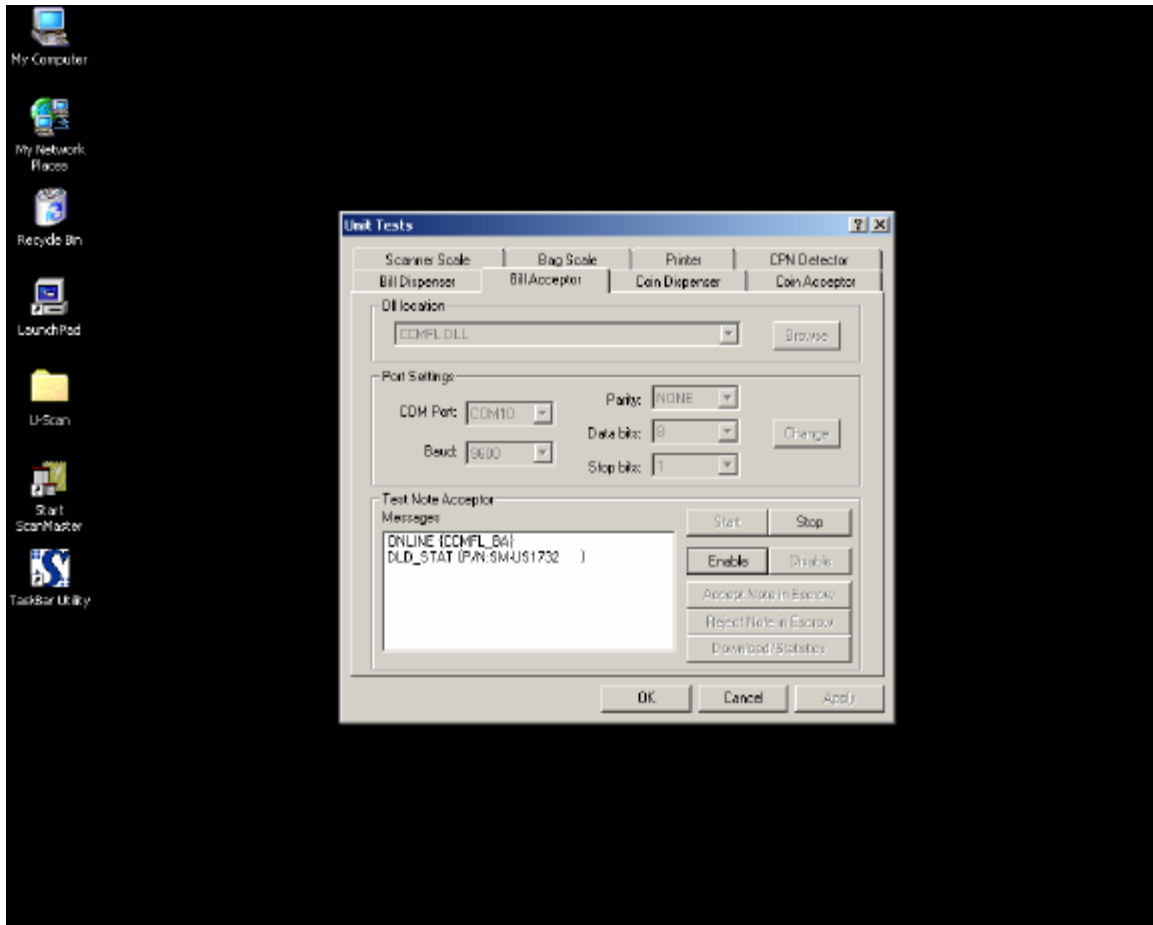
You can also check Device Tester and should see the new P/N listed as P/N is SM-US1732
