**Subject: TP2000 Retail I/O Board (90000161) and TeamCOMBO Board (90000273)**

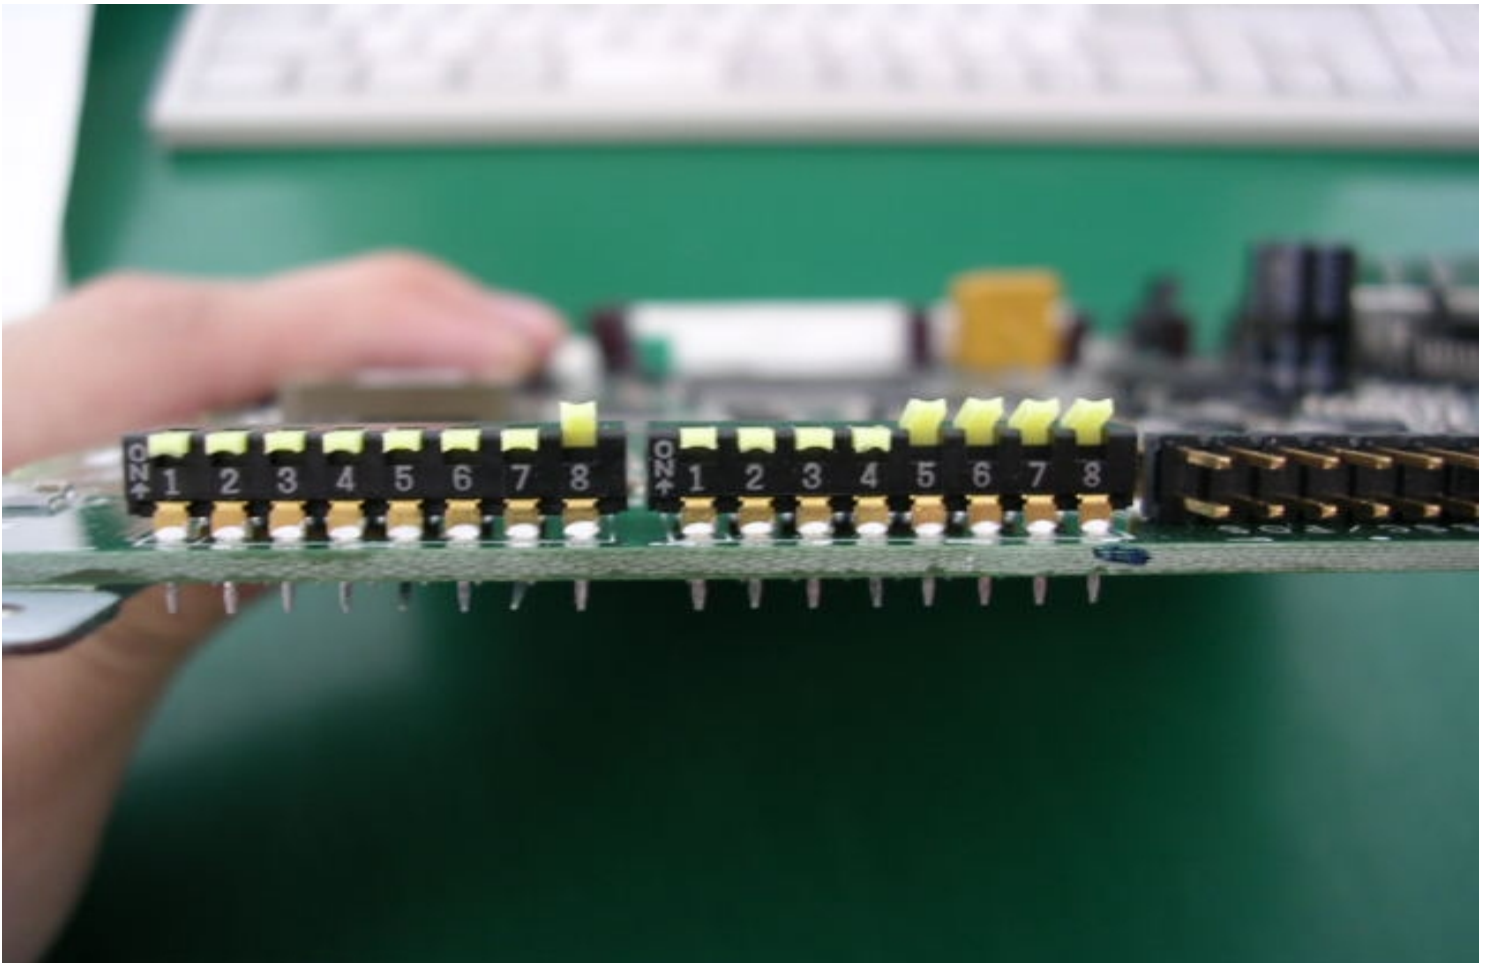
There is a possibility of inaccurately setting switch packs (SW3 & SW4) on the Retail I/O board and switch pack #3 (SW3) on the TeamCOMBO board. The TeamCOMBO board (90000273) only has one switch pack (SW3); while the Retail I/O board pictured below has two switch packs. There are two different types of switch packs approved for the TeamCOMBO board. One switch pack is set to "ON" when the switch is in the up position, and another has the switches set to "ON" when the switch is in the down position. In order to accurately determine how to set these switches, a visual inspection of the switch pack is necessary. In the picture directly below the arrow is pointing upward just below the word "ON". This is the most common switch pack on the Retail I/O board and indicates that the switch is in the "ON" position when up (away from the board).

"On" is in the up position  
SW4 & SW3 pictured above on the Retail I/O Board

Please verify the switch pack settings by visually inspecting the arrow position on the board after replacing a Retail I/O or TeamCOMBO board. Simply setting the switches the same as the previous board without verifying which position is "ON" could result in a board that doesn't function. The table on the following page shows the switch pack options.

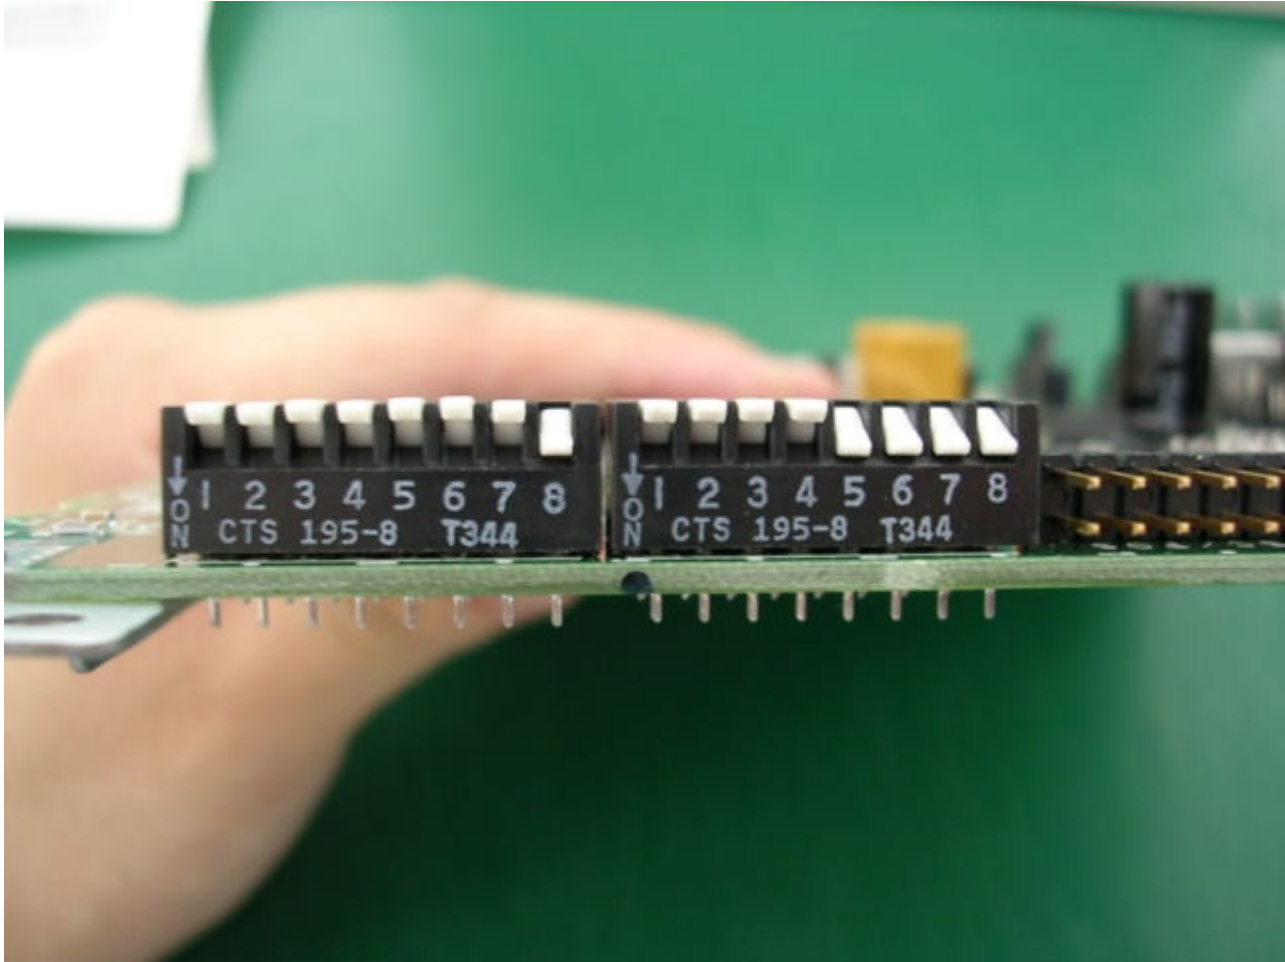
"On" is in the down position (Retail I/O board Pictured)

The picture directly above shows the arrow pointing downward for the "ON" position. Both switch packs have been approved on the TeamCOMBO board, but only some Retail I/O board will have the above switch pack installed.
