**Subject: New TeamPoS 2000 “M” Digital Video Chip**

**Update A:** Updated to show new BIOS is NOT Downward compatible. Changes are highlighted.

**Update B:** Information added to show specific instructions related to loading the driver on a U-Scan system.

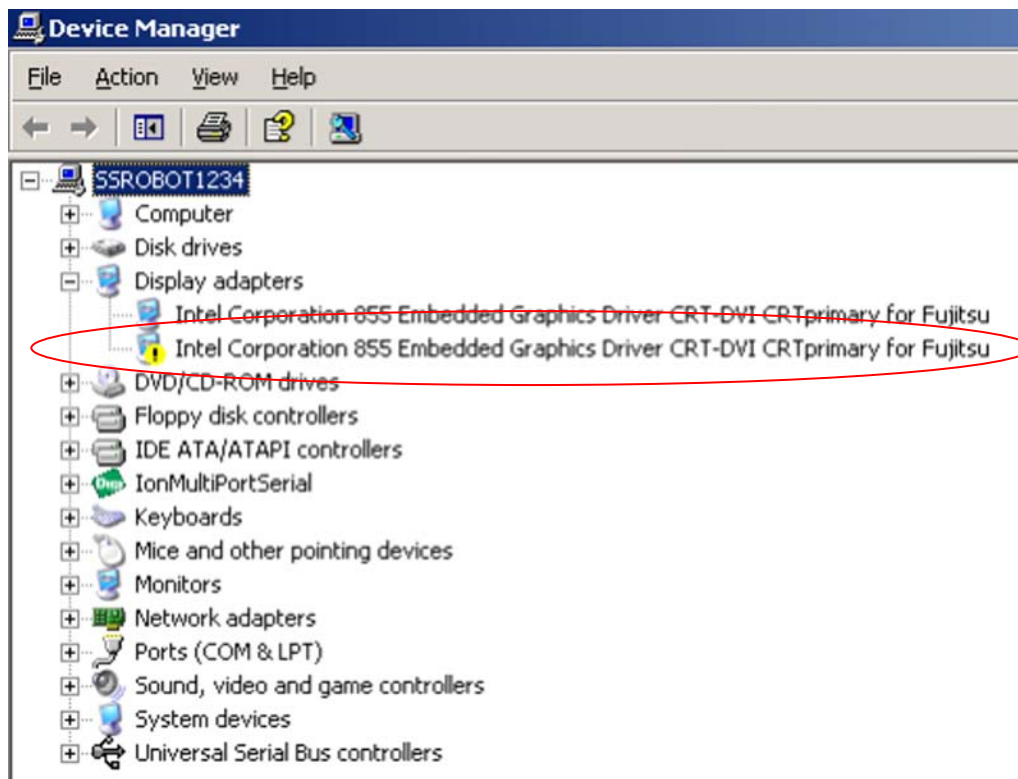
5. On this screen check “Display adapters” to check for an error
6. If an error exists you will need to load the new video driver
