Subject: Genesis U-Scan Weld on Gas Strut

Potential weakness in weld on Genesis U-Scan gas strut mounts.

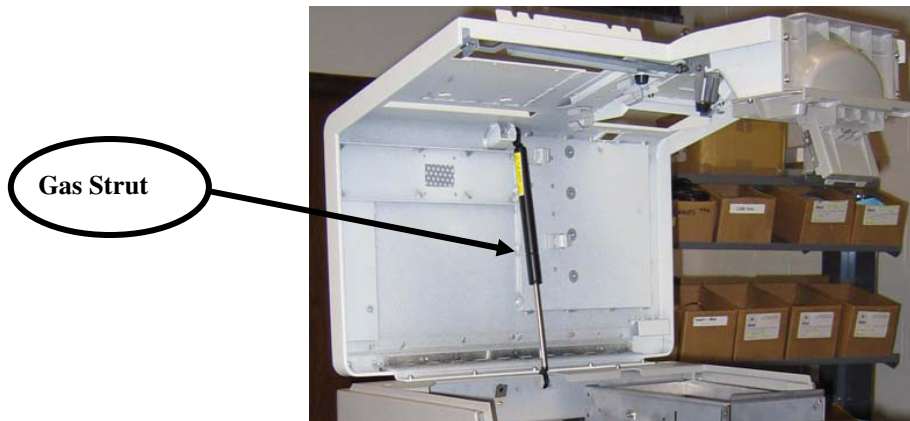
During our quality inspection process, we have discovered a potential weakness in the weld for the gas strut that holds open the top door (see picture below). It is unlikely that this will cause any problems in the field; but as a precaution we are sending this notice to inform you of the potential failure and will follow up with a field modification to add a safety bracket.

Until the Genesis unit has been updated with a safety bracket you should hold the door open when reaching or extending any part of your body under the door. We expect that safety brackets will be issued to the field for installation early November 2007.
