Subject: SBU Sensor Array Control Box Connector

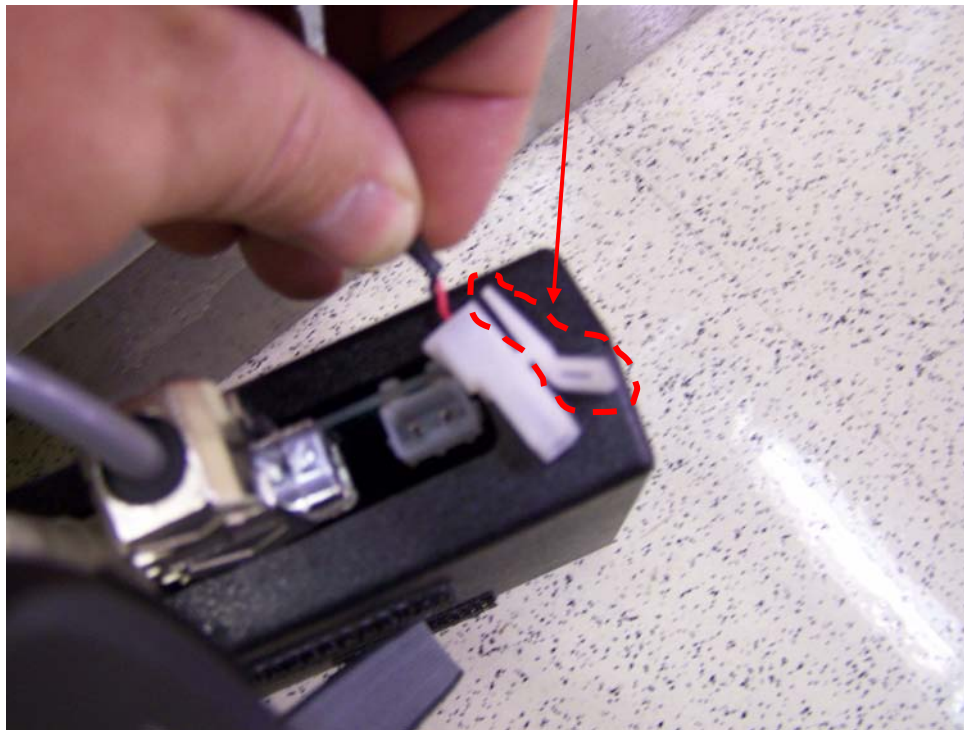
Connector P2 Retainer tab mates with the controller circuit board which cannot accommodate the retainer so it was bent back in order to be installed. The plastic tab eventually tries to return to its original shape and pushes the connector away from the board making the connection intermittent.

(TAB) Cut Off

If there are any installations with P2 Part # 11000534 with the Tab still attached, please remove (Cut Off) the Tab.
