**Subject: MicroCoin Cable Routing**

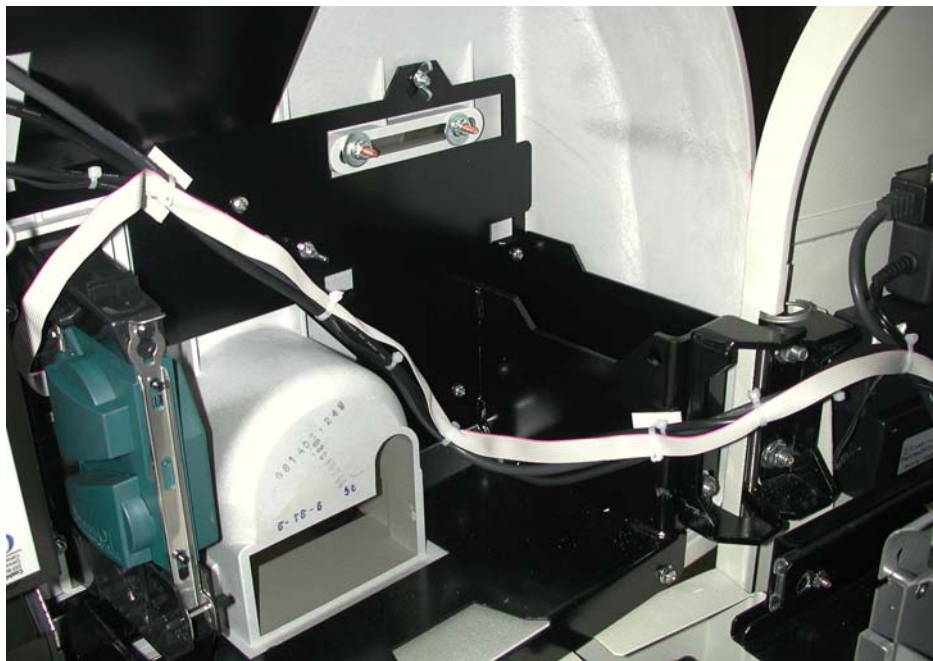
There have been reports of the ribbon data cable from the MicroCoin Coin Dispenser getting frayed and/or damaged by repeated opening and closing of the cabinet door. This has been attributed to inconsistent routing and securing of the cable during production.

On a next visit basis, ensure the cables are routed and secured properly to prevent excess wear when the door is opened. Using approximately 7 tie-wraps, secure the data cable as illustrated below. The ribbon cable needs to be kept clear of the hinge area and the coin dispenser as the door opens and closes
