Subject: Telequip Slide Assembly Screws

Coin dispenser mounting rail screws coming loose causing jams in the slide rails.

Rev A: Updated to include improved illustration to more clearly identify target area.

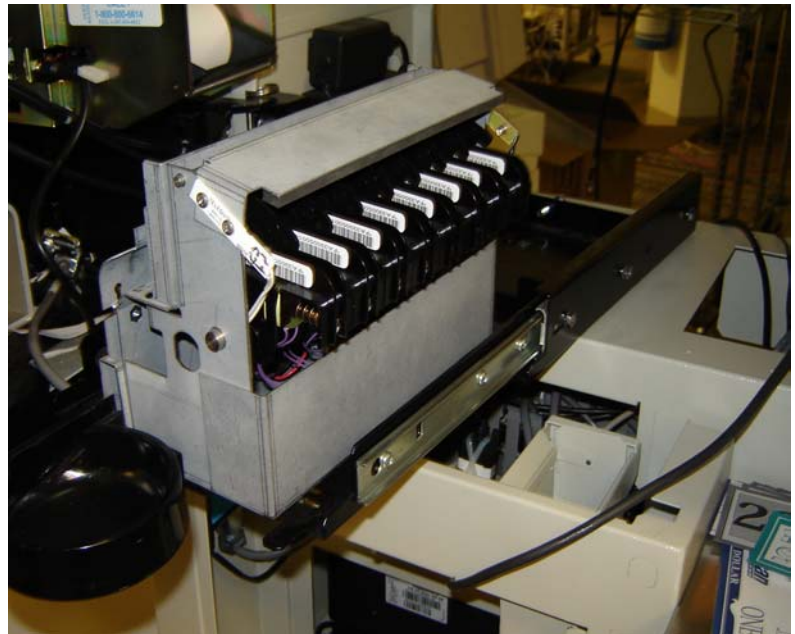
View from the Front #1

Not all screws used in the slide rails assembly are applied with Loctite. Because of this, some screws are coming loose in the slide assembly and falling into the rails causing the rails to jam, unable to move in either direction.

If this scenario happens in the field, the FE should re-install the screws making sure they are all applied with Loctite.

During any service, the rail screws should be inspected, if they are found to be loose should be tightened. Loctite (or similar thread-locking compound) should be installed if not already done.
