Subject: TeamPoS 3000 XL Printer Problems

Overview

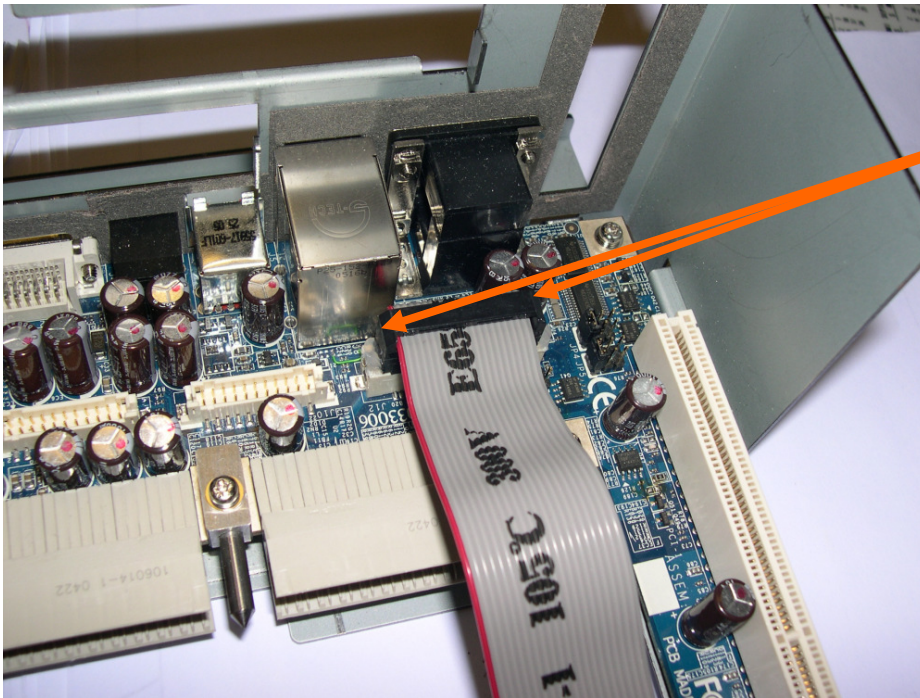
1. When equipped with a Combo board (Intelligent PIN = XMXX3XXXXXXXXXX), the printer may become intermittent as a result of a loose connection on the docking backplane. This is because the cable going from J12 on the docking backplane to the combo board may work itself loose in shipment or handling. See picture below.
2. When the Combo board does not have the jumper pack PRT1-7 jumpered for the correct printer (RS-232 interface)
3. When replacing a DT50III printer with a DT50II printer the OPOS settings will point to the wrong printer.

RTV
adhesive
applied
here

1. To insure the cable does not work loose during shipment an EC has been generated to apply a RTV silicon adhesive during manufacture. This should not affect existing terminal that have been installed for more than two weeks, but it is something to check for in case the terminal is showing intermittent printer problems. See attached pictures for the EC.
