**Subject: TP3K XE Port Switch Label Incorrect in I&M Manual (D900000171).**

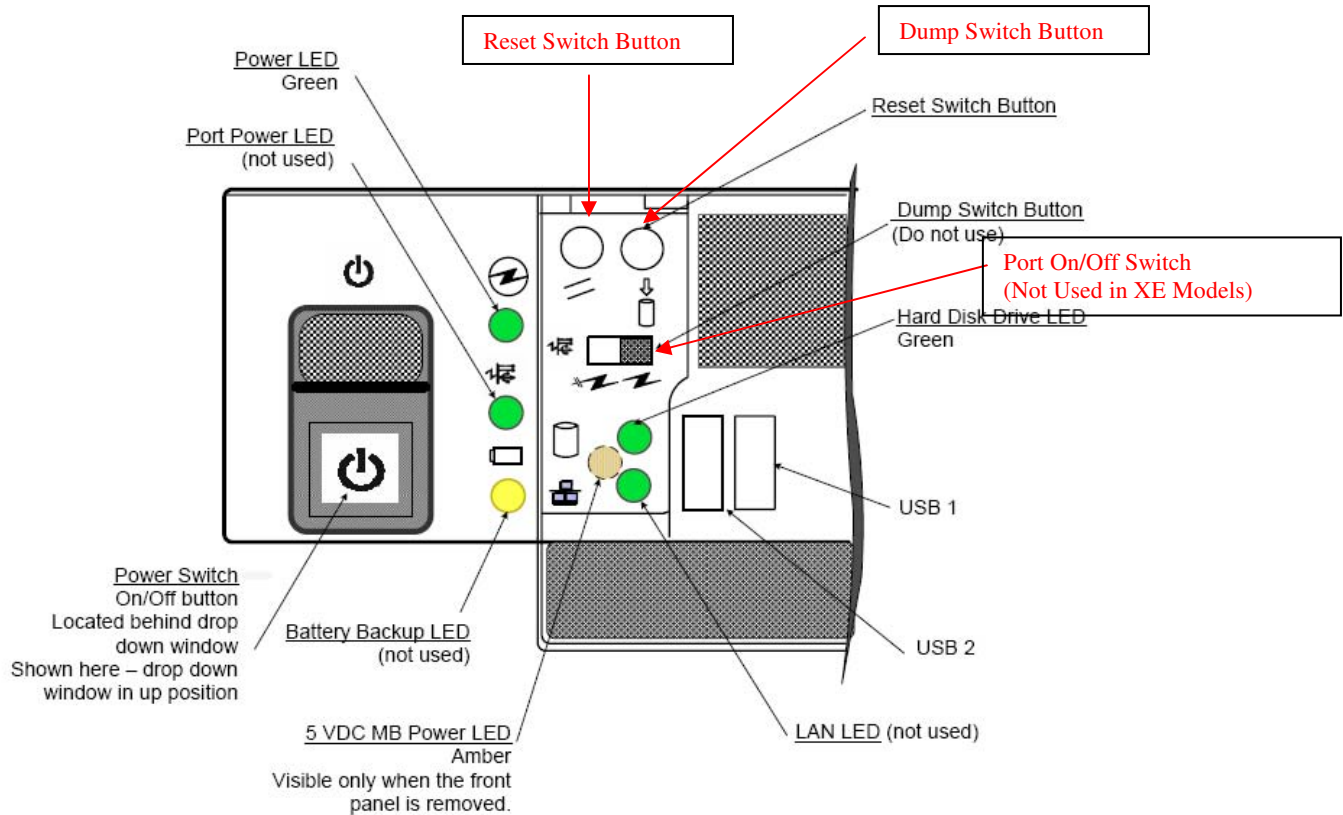
TP3K XE Port switch label is incorrect in the Installation and Maintenance Manual (D900000171), section: 1.1 page 17 of 135 .

**Corrections to be made in RED:**

All corrections will be made on the next scheduled update to the manual.
