**Subject:** U-Scan Genesis Bill Acceptor Hinge and Lanyard Field Replacement

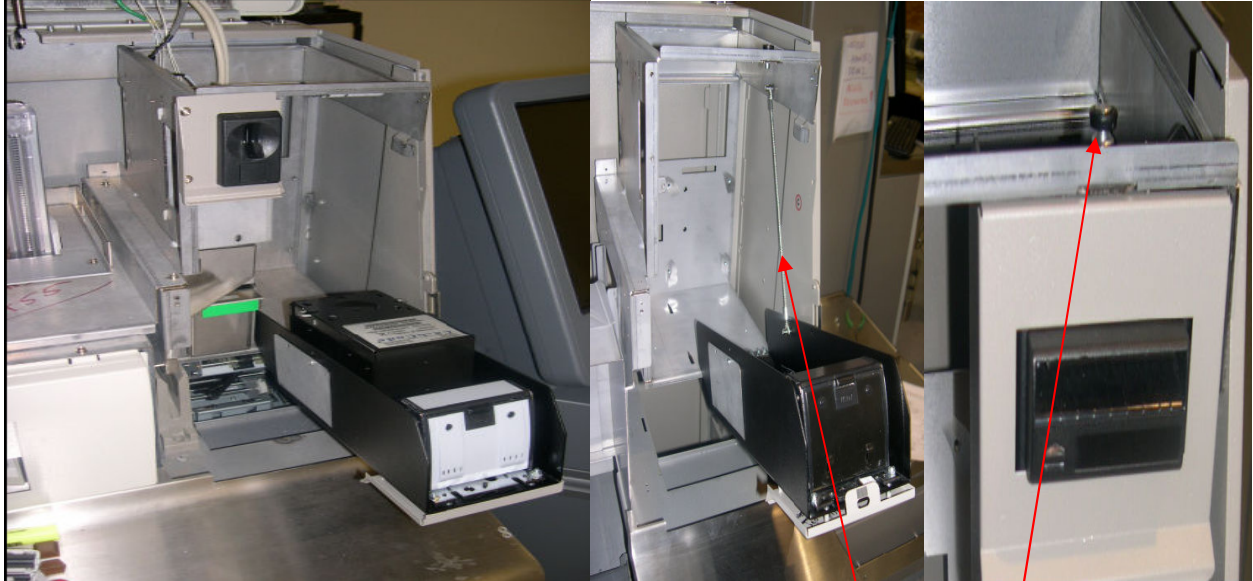
- If the Robot is missing the Plunger or Lanyard but has the appropriate threaded holes, the unit needs the upgrade. Depending on your CashCode unit you will need field kit 11002376 or 11002377.

Unit without Lanyard or Plunger  
(Needs Upgrade)

Unit with **Lanyard** and **Plunger**  
(Does not need Upgrade)

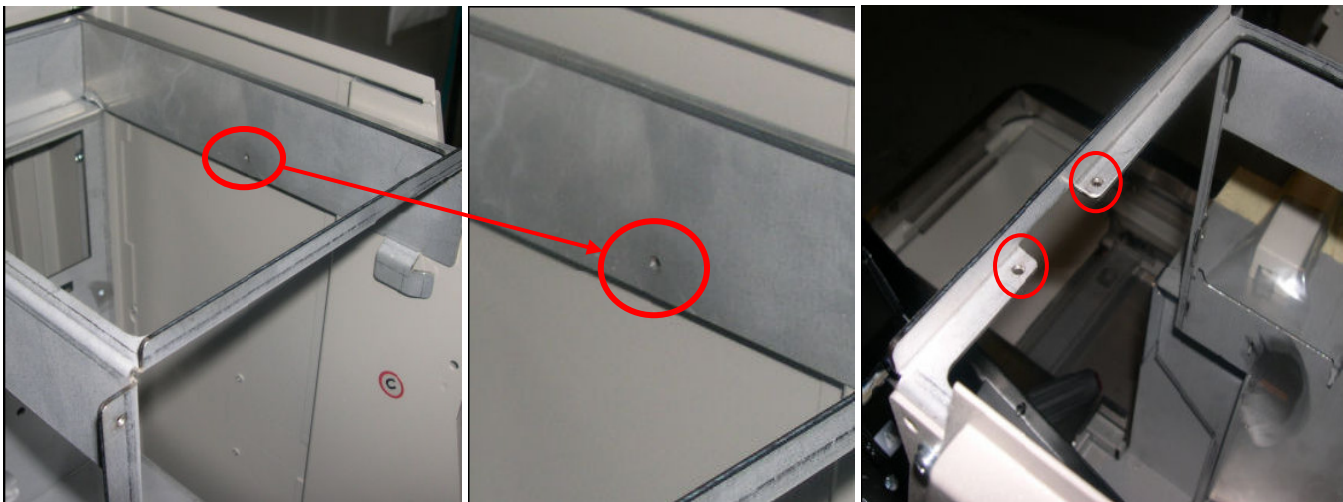
If the Robot is missing the threaded hole where the Lanyard goes or if the threaded holes are missing where the plunger goes the frame must be replaced to perform the upgrade. See illustrations below:

\*If the Frame needs to be replaced please email Sustaining Engineering at [SustainingEngineering@ftxs.fujitsu.com](mailto:SustainingEngineering@ftxs.fujitsu.com) for documentation. Be prepared to supply the following information:
