**Subject: Genesis Bill Acceptor Plunger Latch Breaking**

**Issue**

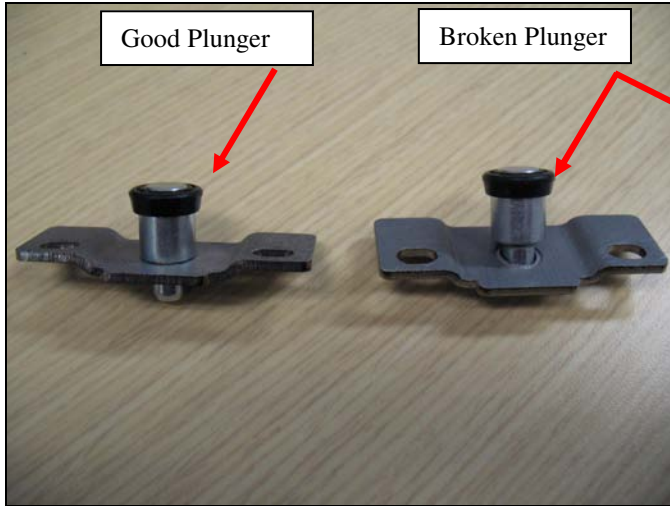
**Illustration 1**

There have been some reports of the Top Plunger Latch breaking off when closing the Bill Acceptor. If the ramp feature is not angled correctly, the flat lead-in edge could shear the Plunger Body completely off. See Pictures below:

1. Make sure all the Bill Acceptor Hinge Screws are tightened, add Loctite if they must be tightened.
2. The ramp should be at a 20 degree angle per drawing below. If the lower lip of the ramp hits the plunger, carefully bend the ramp lip with pliers so the lip will go under the plunger (See Illustration 4). Also make sure to check that the 2 screws on the plunger assembly are screwed on tightly and if needed add loctite.

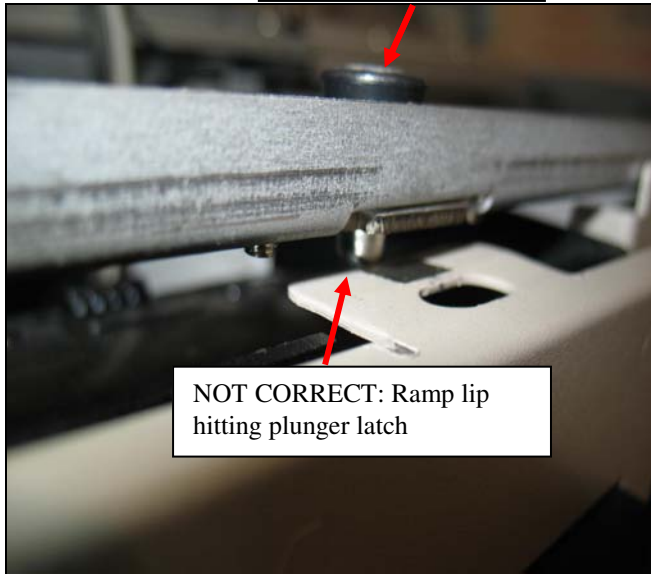
**Illustration 3**

Top Plunger assembly
