Subject: New Touch Controller Board for the D22/D25 LCD Displays

D22/D25 Touch Controller Upgrade

Fujitsu Transaction Solutions	FIELD CHANGE AUTHORIZATION	FCA-08-008
	Sustaining Engineering		EC-14974
	San Diego, CA; Montreal, QC		June 06, 2008

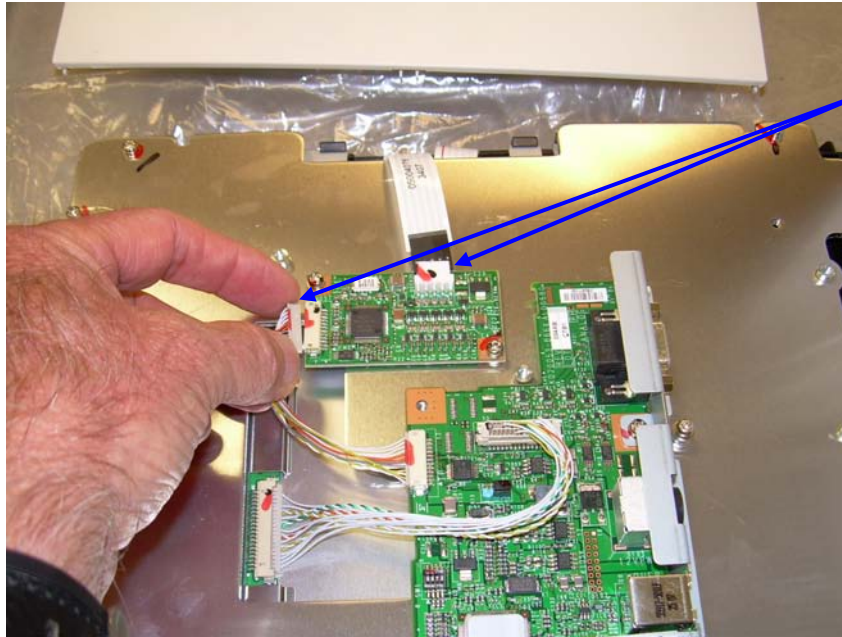
Remove
two cables

5. Be careful when removing the two cables connected to the touch controller board. The cable on the left is easily damaged.
