Subject: Cash Drawer Cable Restraint for TeamPoS 3000 XL Terminal

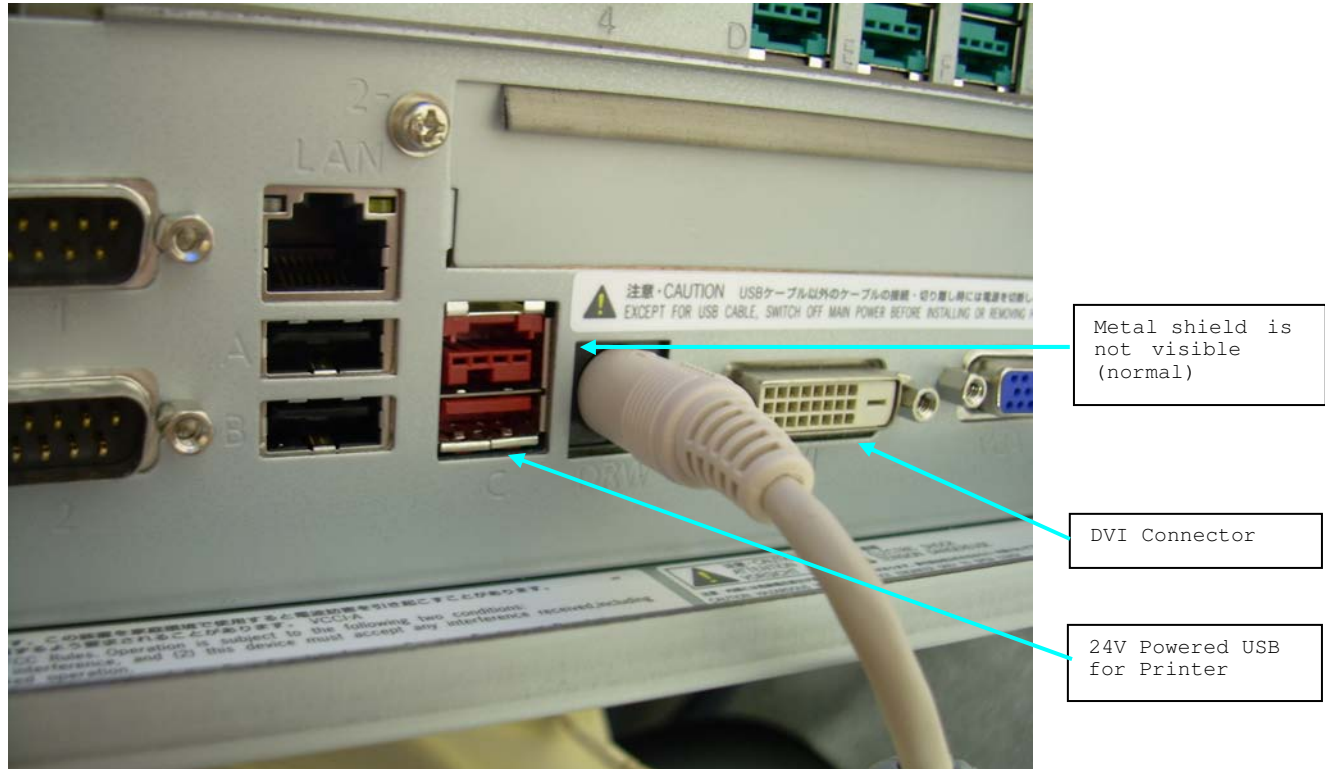
The TeamPoS 3000 XL terminal has had some reported cases where the cash drawer cable was coming loose from the back of the terminal resulting in a service call. Some of the earlier controllers had a metal shield around the connector that was slightly off center preventing the cash drawer cable from being fully inserted. The picture below shows the cable fully inserted.

If the metal shield around the cash drawer connector is interfering with the cable being fully inserted, try to align the metal shield by loosening the standoffs and screws on the backplane board and realigning the metal shield. If the metal shield cannot be aligned, a replacement docking backplane should be ordered. In the case where the metal shield is not preventing the cable from being fully inserted, yet the cable still falls out occasionally, then the best method to secure the cable would be with a cable clamp tying the cash drawer cable with a neighboring cable (DVI or Powered USB Printer) that locks or screws into place.
