Subject: TeamPoS 2000 M Motherboard BIOS

This affects the TeamPoS 2000 M Motherboard, part number 90000759 (USA0213244).

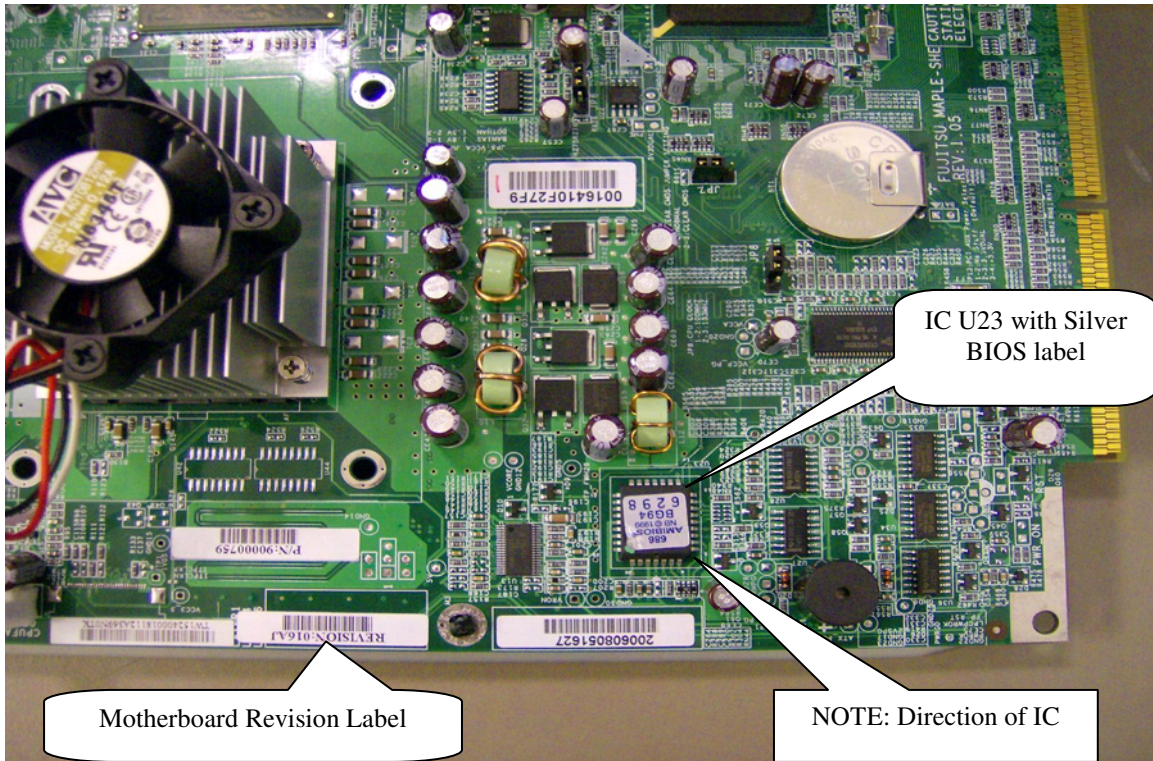
Motherboard Illustration

1. Remove the Silver BIOS label from IC U23 and save for future use
2. Check the part number on the BIOS chip:
If the chip is labeled SST 49LF004B, then do the following:
 4. Re-apply the Silver BIOS labels removed above
 5. Change the Motherboard Revision Label to be revision 0020AN
 6. Verify BIOS v44 is installed, reload if not
 7. Continue any other repairs or normal process, this board is now completed.

If the chip is labeled PM 49FL004T-33JCE, then do the following:

4. Remove (De-solder) the IC U23 from the board
5. Solder the new IC loaded with BIOS v044 onto the board, be sure to note IC orientation
6. Re-apply the Silver BIOS labels removed above
7. Change the Motherboard Revision Label to be revision 0020AN.
