**Subject: TP3K Front Panel and Reset Switch**

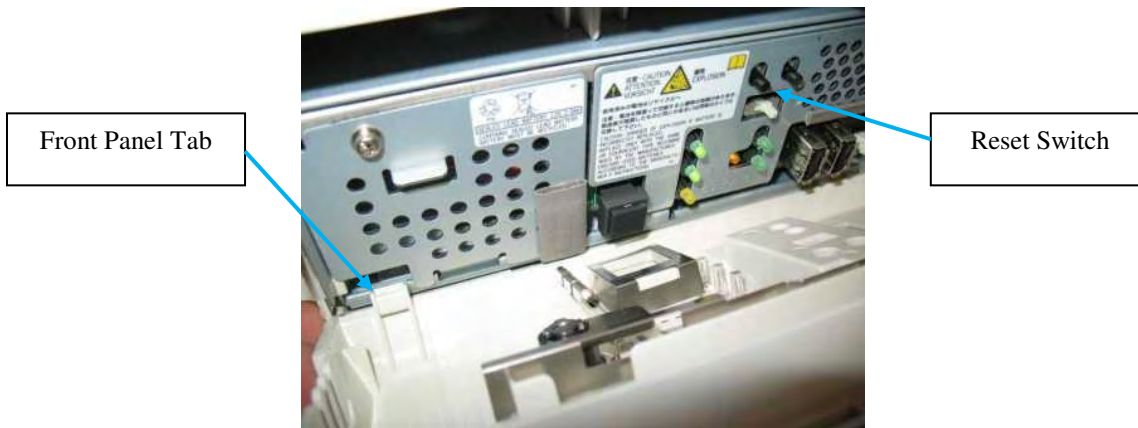
TeamPoS 3000 XL Shown, XE Similar:

This has been traced to a broken Front Panel mounting tab.

If the lower tab on the Front Panel (left side when looking at the front of the terminal) is broken, the panel will not seat correctly and could put side pressure on the Reset Switch that extends through the panel.

Replace the broken Front Panel and make sure it is securely installed.
