**Subject: Genesis Bill Exit Tray Squeaking when Door is Closed**

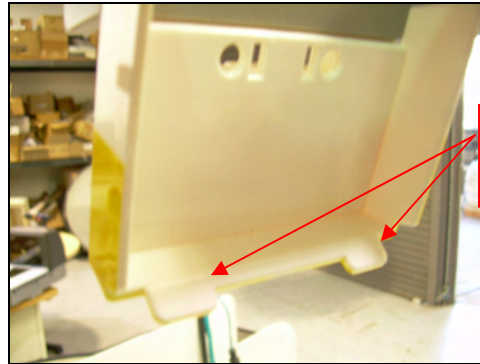
The shaft in the Bill Exit Transport is rubbing against the plastic Bill Tray in the door. There are a few things that can contribute to this issue like missing rubber bumpers or the Bill Tray not secured properly.

Make sure Tabs are smooth with no blemishes.

1. Make sure F53 Unit is properly secured.
2. Make sure F53 Bill Exit Transport is properly secured.
3. Verify Door Rubber Bumpers are installed and properly placed – **See PSB-08-029.**
4. Verify door plastic Bill Tray has no blemishes like mold marks, file smooth if needed.
