Subject: F53 Cassette Locking Tabs Bending

Fujitsu Frontech NA	PRODUCT SUPPORT BULLETIN	PSB-09-008
	Sustaining Engineering		OHIR418
	San Diego, CA; Montreal, QC		April 24, 2009

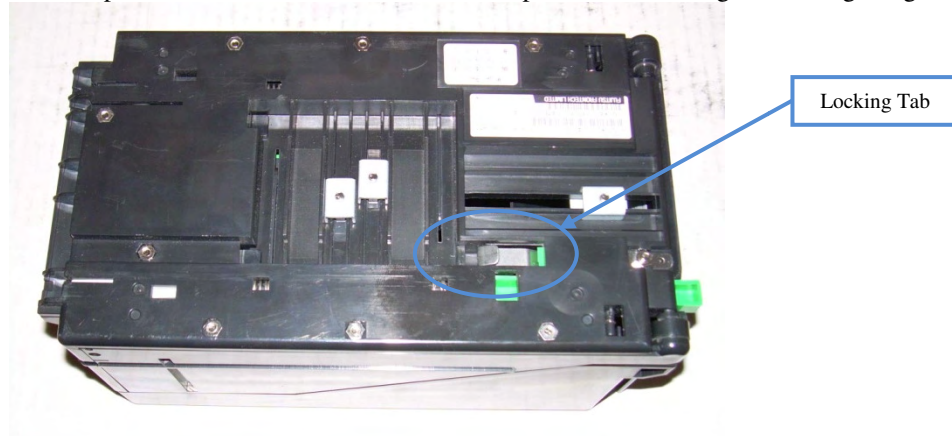
Bottom of Cassette

Reliability improvements have been implemented to the F53 BDU Cassette to prevent its Locking Tab from getting bent.

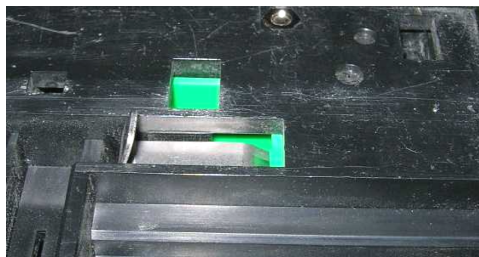
Bent Tab

If the tab gets bent slightly, it will then catch on the metal base of the F53 Main Unit which bends the tab even further. This makes the cassette difficult to insert, can make it difficult to release and remove, and can also cause the Cassette to make a grinding noise when operated.

Replace Metal Locking Tab with stronger version.

- KD02881-E531 Cassette Locking Metal Tab (rev 10).
- This change was cut into Cassette production: Rev 10F or above, cassette serial #KA00045793.
- The Locking Tab part number did not change, all future orders of this part will be the new revision.
- The only visible difference is the new Tab is Thicker/Heavier metal (1.5mm instead of previous 1mm thick).

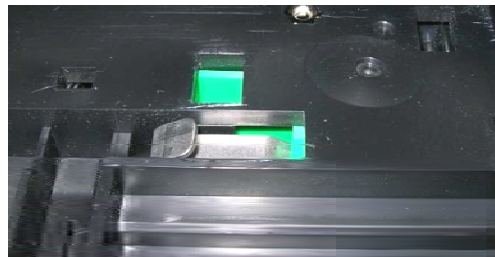
OK Tab
