Subject: iPad Battery Charger Contacts

Overview

An improvement has been made to the iPad Single Battery Charger to improve the reliability and robustness of the contacts within the Charger.

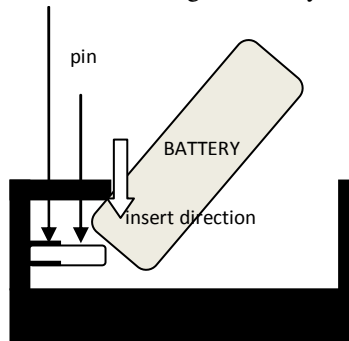
It was found that if the Battery is not inserted into the Charger correctly, the Battery can press sideways on the Contact Pins and cause them to bend or for the contact joints to break resulting in an early failure of the Charger.
