Subject: New F53 Dispenser Firmware for U-Scan

A new version of firmware is being released for the F53 Bill Dispenser that is used in the U-Scan system to fix a problem with the thickness sensor adjustment procedure.

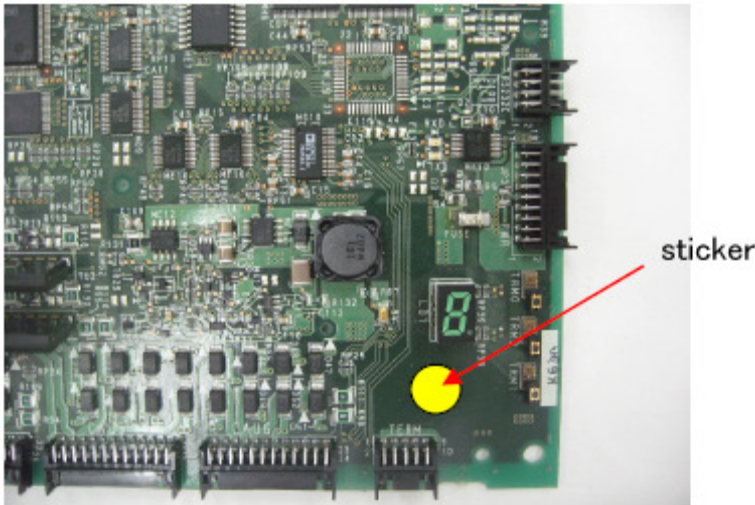
All new F53 units and spare boards listed below ordered after cut-in will have a yellow sticker on the board, as shown below, to indicate that US0300 firmware has been loaded. Spare PCB boards should be ordered using the new part number KD03234-K900 so that they come with the correct firmware. All units upgraded in the repair center will have the sticker applied.
