Subject: Currency with Metal Security Strip Causes Jams in F53

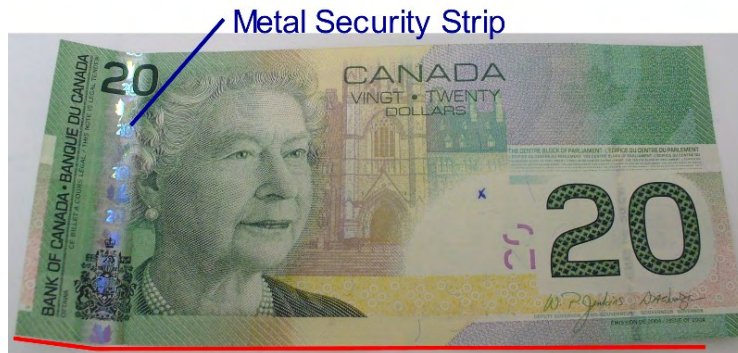
Currency with a wide metal security strip, like the Canadian \$20, tend to have a natural upward curl at the end where the metal strip is located. If the notes are loaded with the metal strip facing upwards and at the leading edge of the cassette they can fold at the exit and because the metal strip does not fold completely the note may jam at the exit. The jam will be more frequent if the leading edge of the note stack is not squared up neatly.

To avoid jams, the notes should be loaded with the metal security strip at the back of the cassette away from the pick rollers. It is also important to make sure that the leading edge of the note stack is squared up neatly to prevent notes from curling up at the exit slot. See below for bill loading instructions.
