Subject: TeamPoS 3600 USB Error Message

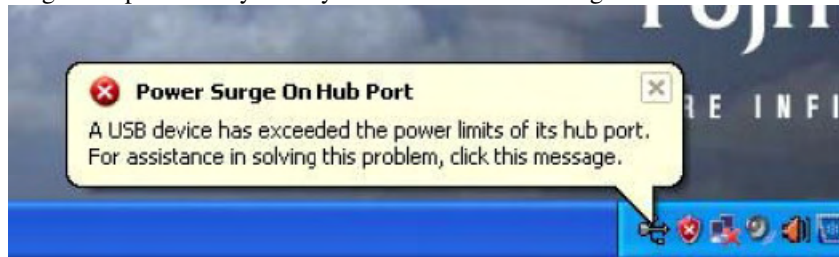
A Windows pop-up error that indicates one of the USB ports detected an Over-Current condition could be displayed shortly after startup or during operation. This is a false error. All ports are fully functional and there is no impact to the terminal operation. The error can be cleared (though could show up again) or not. Depending on the customers application, screen overlays, and security settings the operator may or may not even see this message if it occurred.

If the error should be seen in the field and causes impact, the motherboard (11003001) should be replaced with a Rev2 or later board. The removed board should be returned for warranty repair/replacement. The solution is the addition of 4 resistors to the motherboard. This changes the motherboard revision from Rev1 to Rev2.

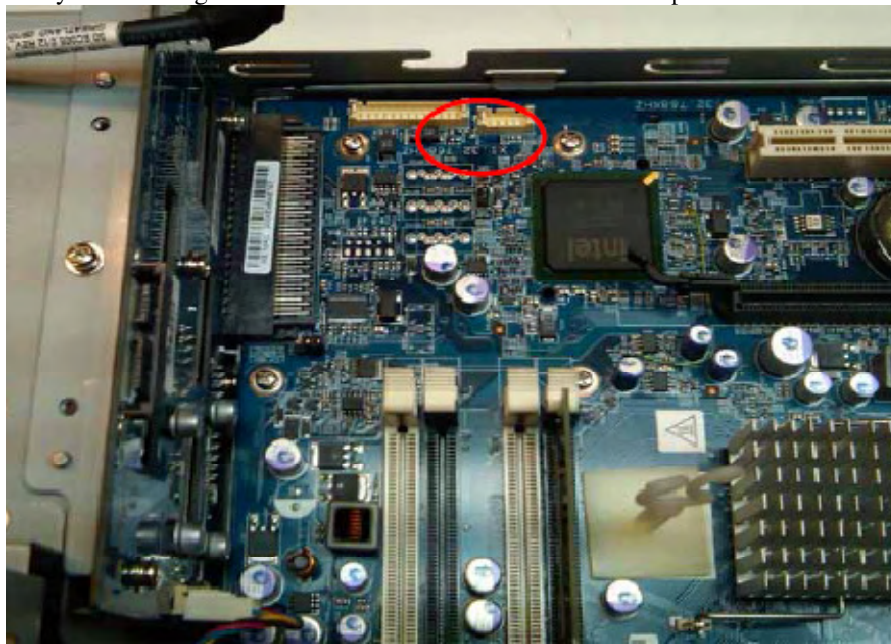
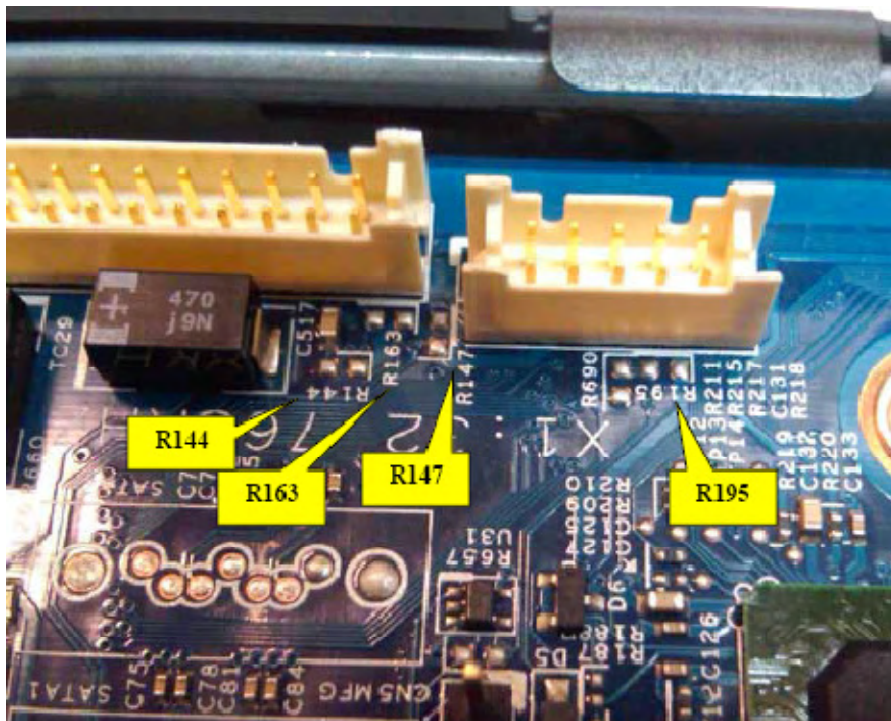
Below are illustrations of the Motherboard identifying the 4 components that are added to correct this error. Rev1 boards do not have these components, Rev2 boards have all 4 components installed. This information is provided for Informational and Identification purposes only. Field changes or rework to the motherboard is NOT implied or authorized.
