Subject: Datalogic 8500XT/XTS Scale

Overview

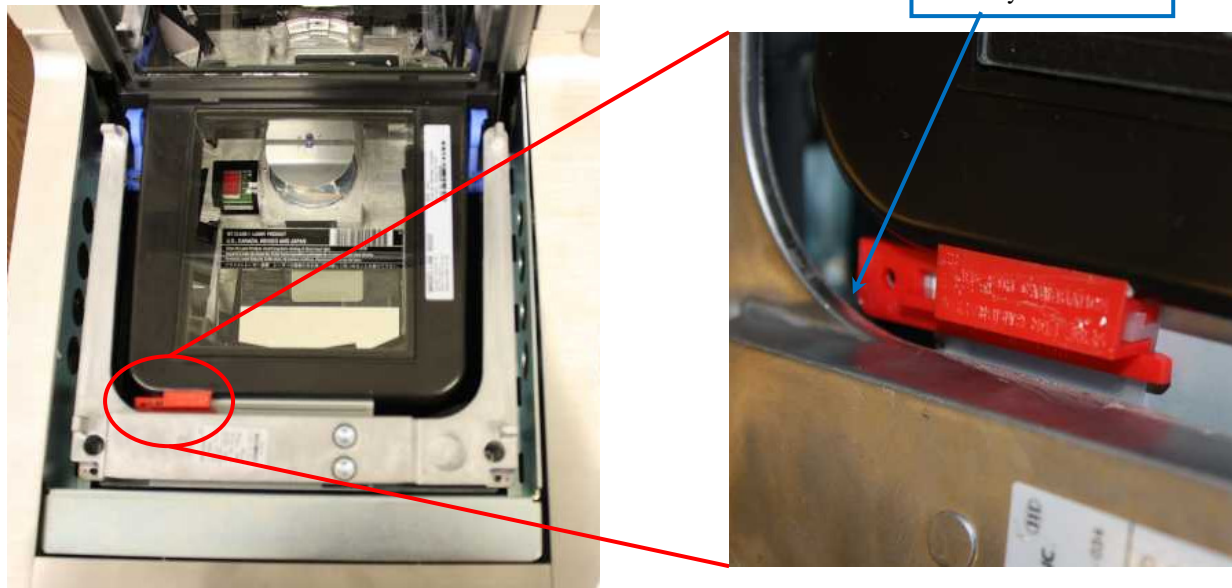
Installed Scanner/Scale (Platter Removed)

The problem was found to be the small red slide cover that protects the Calibration button on the scale was coming in contact with the loadcell and/or weigh arms of the scale. This is the cover that is used to ‘seal’ the scale by local Weights and Measures personnel.

When installing or servicing these units, verify that the red slide cover is snapped down into position on the scale frame and is clear of the loadcell and scale arms. There is typically approx 1/8” - 1/4” clearance between this cover and scale arm.
