Subject: D22/D25 Display Connector Failures

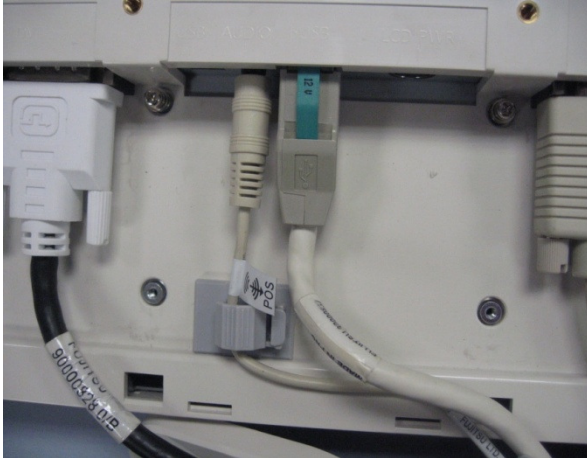
The damage seen to the P-USB Connector is typically that the connector has been stressed sideways and has caused one or more of the soldered connections to fail or pull loose from the PCB.

In many cases this is due to the lack of a strain relief on the P-USB cable upon installation.

Incorrect Installation

During Staging, Installation, or any Service Call where the display is opened, make sure the cables are all properly attached and strain relieved.

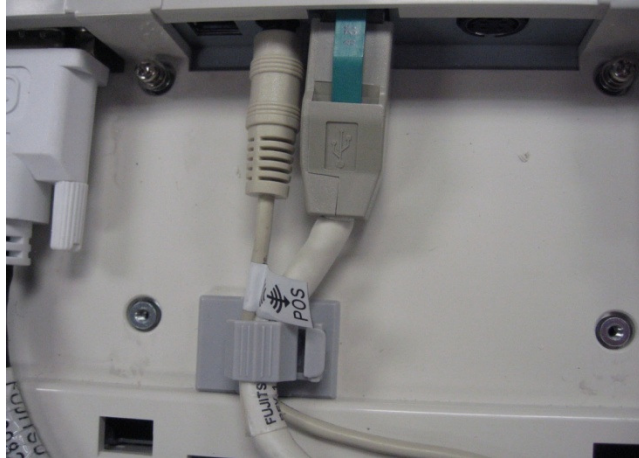
Correct Installation with Strain Relief
