**Subject: TeamPoS 3600 Internal Connectors**

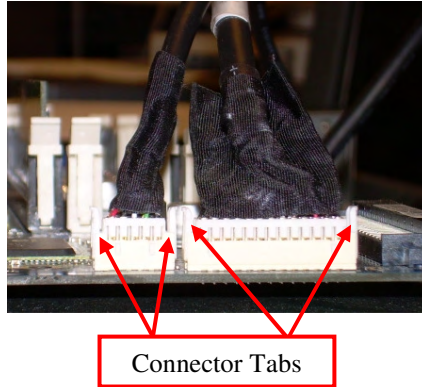
There have been some reports of connector retainer clips being broken in the field when replacing I/O or Motherboards.

The small connectors (examples shown below) have a retaining clip on each side of the connector. When removing one of these cables, the clips must be pressed inward completely and the connector then pulled straight up. If the clips are pressed sideways or outward with enough force, they can be broken off and then will not properly retain the cable into the connector on the board.

- Production      None.
- Installed Units    Care and proper procedure (above) taken when remove these cables from the boards.
- Repair Center    Care and proper procedure (above) taken when remove these cables from the boards.
- Service Spares    None.
