Subject: iPad100-20 Main Board EOL

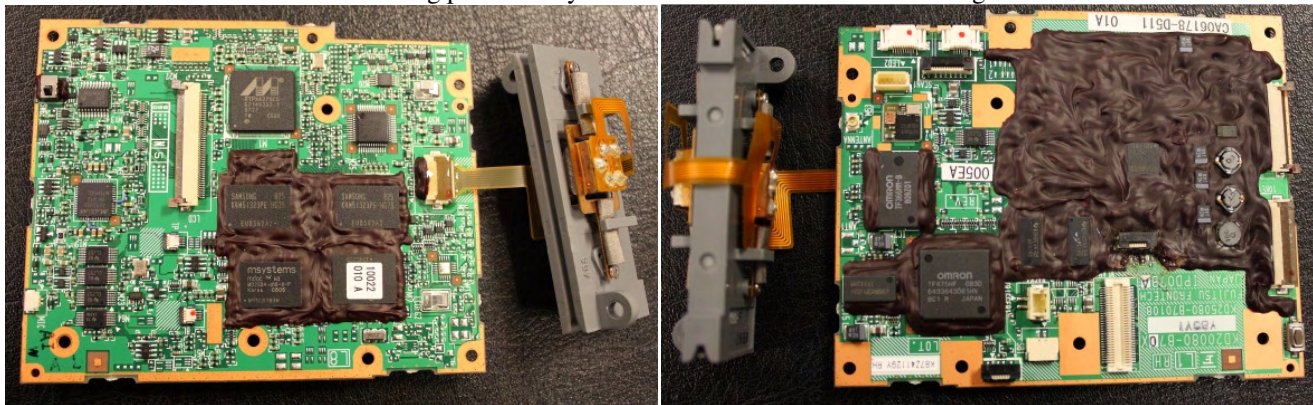
The iPad100-20 Main Board is replaced by a new board. This new board has the MSR reader permanently attached and has a security “conformal” coating in several locations (see below). When replacing the old Main Board within an iPad100-20 with this new board, the MSR will also be replaced. The removed MSR can be cleaned up and if still functional can be returned to spares stock (part number listed below for reference).

Illustrations of new Main Board showing permanently attached MSR and conformal coating on both sides.

- Production None.
- Installed Units None.
- Repair Center When stock of current Main Board (-D510) is exhausted, use new Main Board (-D511) and replace MSR also.
- Service Spares When stock of current Main Board (-D510) is exhausted, use new Main Board (-D511). Note, for repair center use only. Not field replaceable.
