Subject: Genesis Bill Dispenser/Recycler Latch Pin

BDU-BRU Release Latch Repair Kit

This is document number D900000501, Version 1.2.

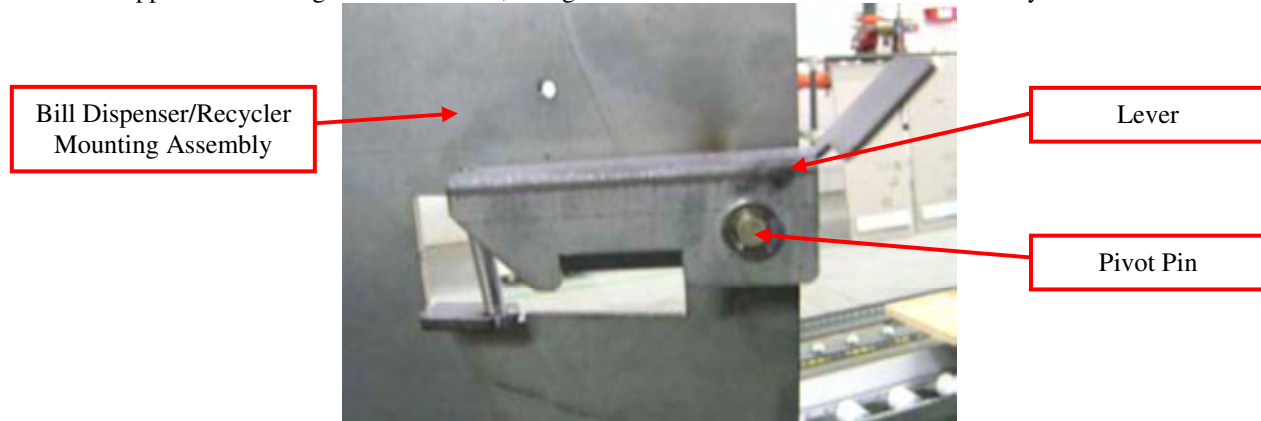
There have been occasions in the field where the retaining Lever Pivot Pin for the Bill Dispenser/Recycler can get broken from the Mounting Assembly. Currently when this Pivot Pin breaks the entire Bill Dispenser/Recycler Mounting Assembly must be replaced. This applies to both Right and Left units, though all illustrations below will be of Left only.

The primary cause of this Pivot Pin breaking is due to a misalignment of the Lever Catch that if the customer slamming BDU/BRU into place causes the Lever to strike the Catch putting excess stress on this Pivot Pin.

There are multiple actions being taken to: 1) reduce the occurrence of the pin breaking, and 2) allow the field to repair the broken pivot pin without replacement of the entire mounting assembly (when possible).

1. A new Lever has been designed that will reduce the stress on the pivot pin. Anytime this Lever is replaced (whether the Pivot Pin is broken or not), only the new Lever should be ordered. This is Fit On Fail or as needed only.

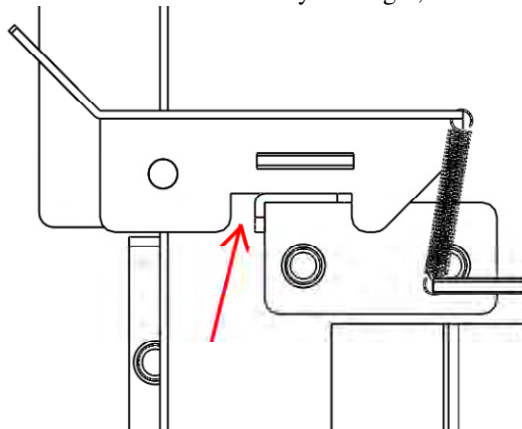
3. The red arrow below indicates the gap that should exist between the Lever and the Catch when the tray is fully racked into the Genesis. This is best verified from the front with your finger, since a visual inspection cannot easily be done.

4. Tighten both Catch securing screws. – Done.

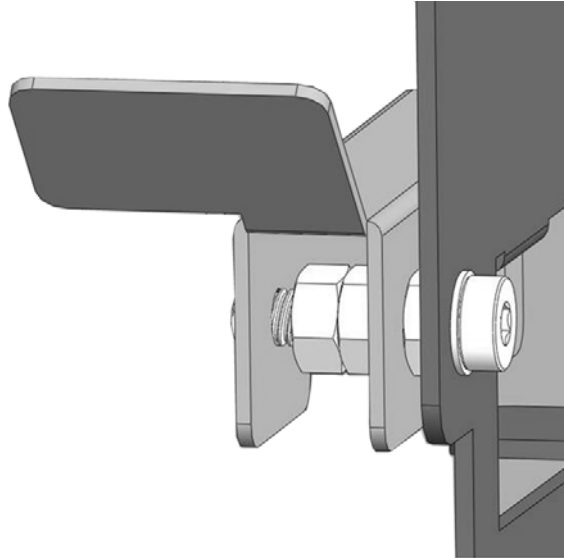
Reports have been received from the field that the Bill Dispenser unit (BDU)/Recycler (BRU) release latch can break if the bracket with which it aligns is not adjusted correctly. This manual describes the procedure that must be followed to correct a broken release latch (latch for left hand station casing shown below).
