Subject: F53 Bill Length Errors with Polymer Notes

Update B: Added information regarding Cassette Width setting.

Update A: A second issue was discovered (belt in wrong position) and documented below.

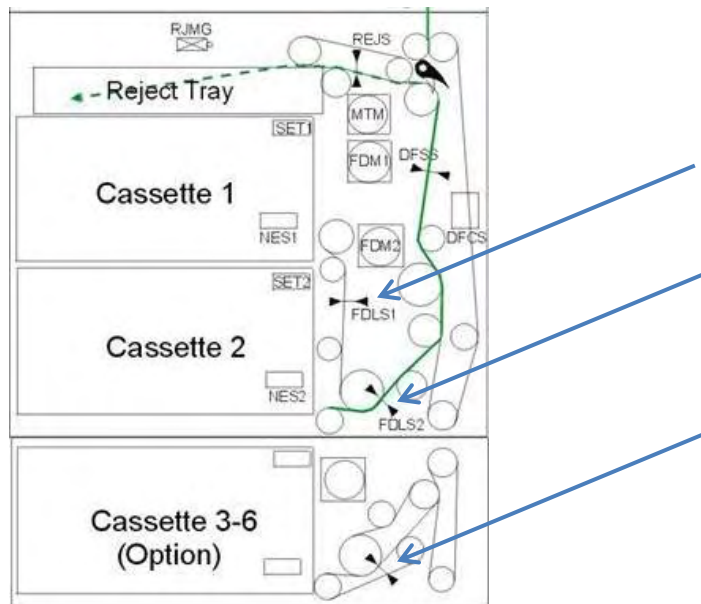
One cause has been found to be with the sensors in the F53 not being able to properly sense the windows in the notes because they are dirty. While the reduced sensitivity of the sensor due to dust/dirt may not be apparent with the use of standard paper notes (solid), the introduction of the Polymer notes with windows required more sensitivity of the sensor to recognize the partially transparent window.

Any geography that begins using Polymer notes for the first time should anticipate these sensors needing to be cleaned on any units that have been installed and operational. In the illustration below, the FDLS sensors (especially #2) are the most critical for this error, though during the Service or Preventive Maintenance all sensors and belts should be cleaned. This illustration below does not show the exit transport (which is different in each version of U-Scan). There is also a BPS sensor in the exit transport that should be cleaned.

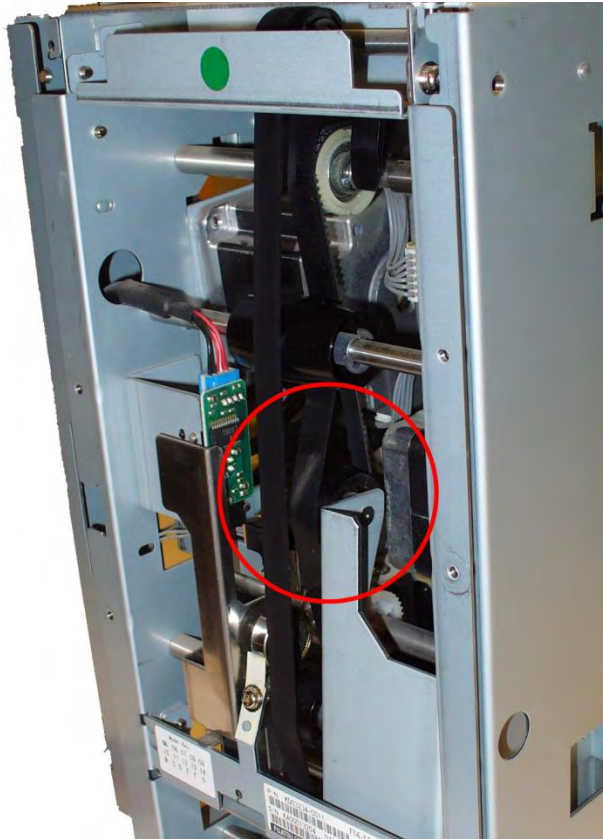
When a customer clears a potential jam in the rear of the unit, it is possible that they inadvertently pull a specific belt out of position. While the unit may appear to continue to function, the bill timing may be affected enough to cause some issues. This is most prevalent from Cassette #2 and with the use of Polymer Notes.

**F53 Rear
Belt in Wrong Position**

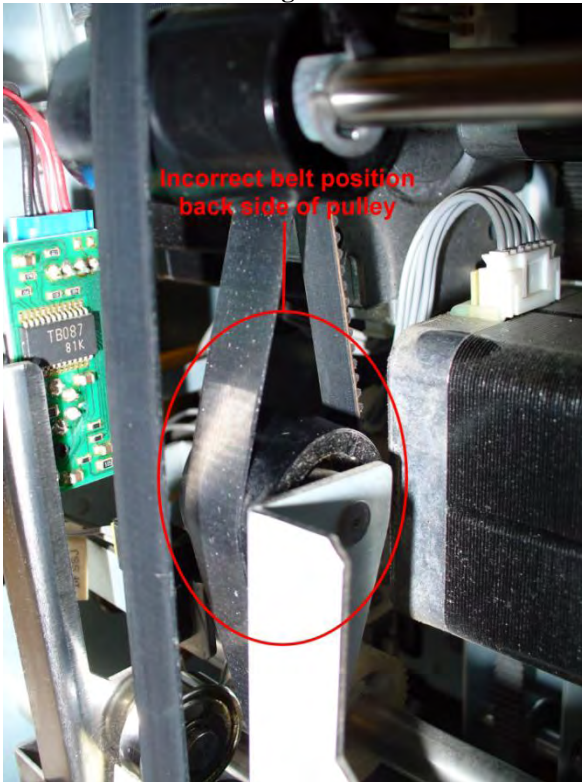
**F53 Rear – Close Up
Belt in Wrong Position**

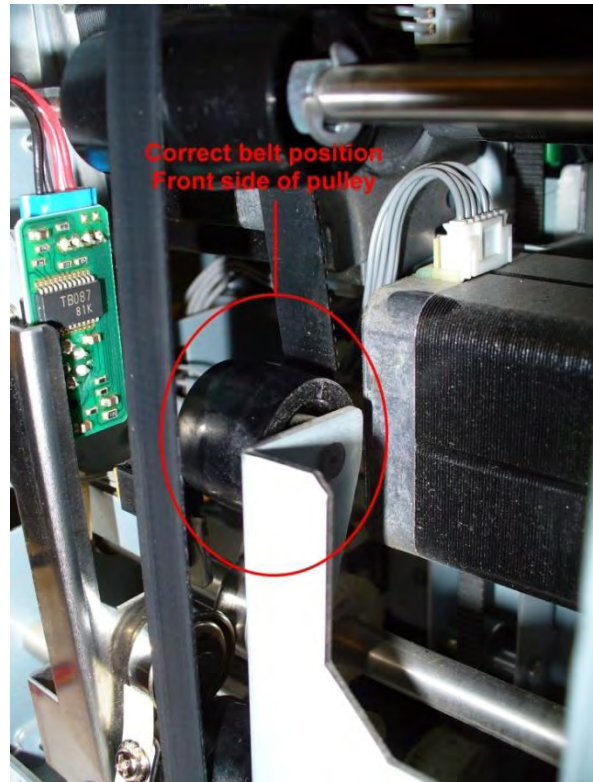
**F53 Rear – Close Up
Belt in Correct Position**

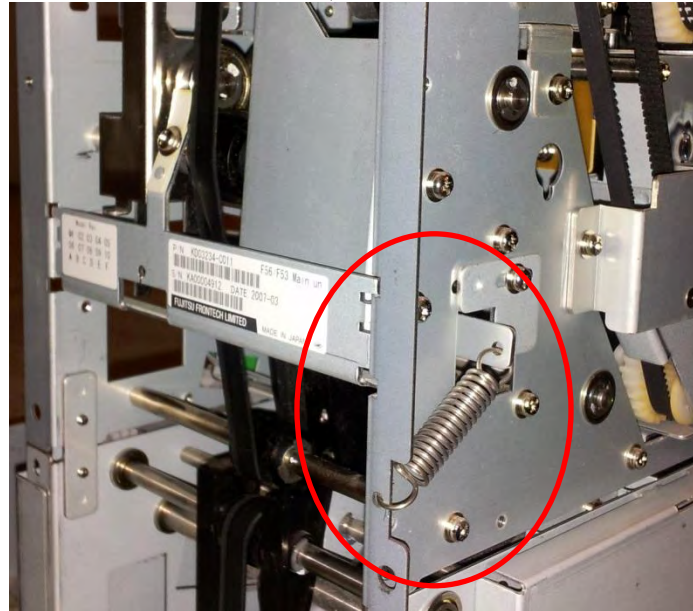
Also make sure the spring (shown below with cover removed) is installed and holds tension on the wheel.

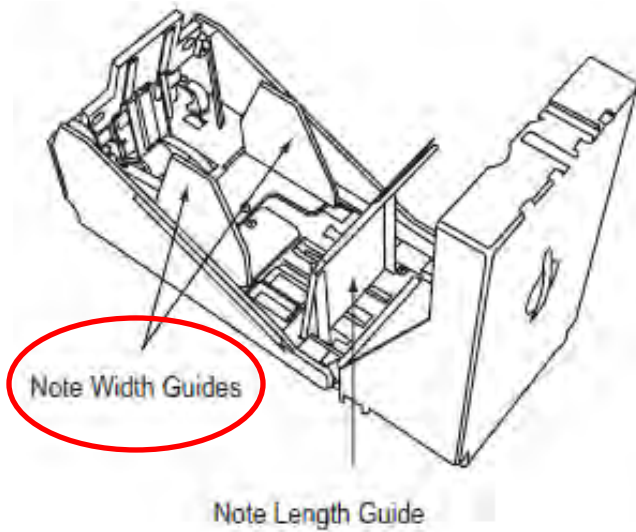
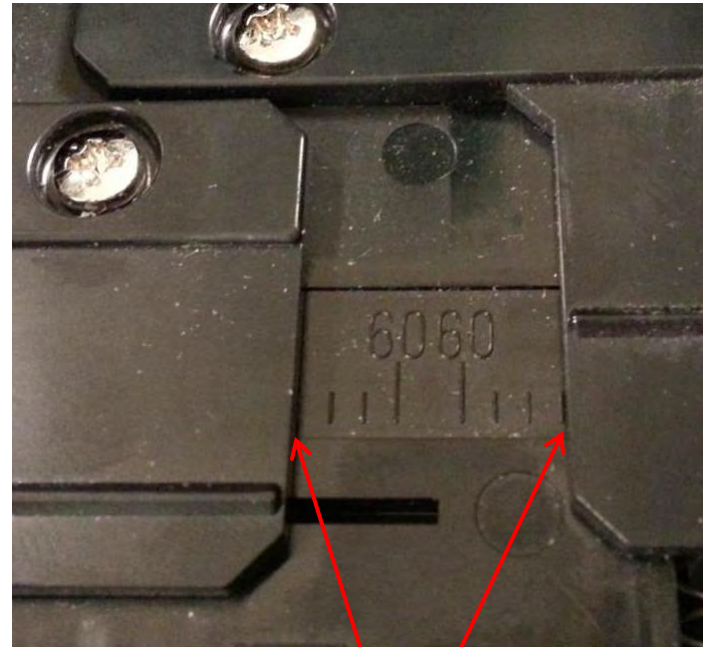
The published dimensions of the new Canadian notes is slightly different that actual measured value of the production minted notes, was documented as 69mm width, is actually 69.85mm. Following testing of the new production notes, it has been found that for optimum performance, the Cassette Note Width settings should be set to 72 on each side (each mark = 4).

3rd Mark from '60' on each side
