**Subject: Genesis Bill Acceptor Hinge**

# Bill Acceptor Hinge Replacement

This is document number D900000512, Version 1.0.

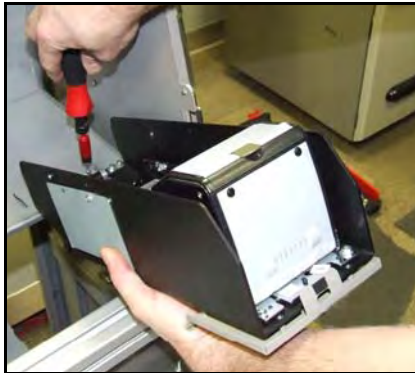
**CORRECT (Supported)**

**Important: Do not allow the bracket to hang loosely while tightening the screws.**

1. Making sure to cradle the Bill Acceptor bracket assembly in your hand as shown below, secure the hinge to the Customer Station casing shelf with the two supplied screws.
