Subject: Genesis Top Door Stopper Spacer

Upper Door Stopper Upgrade

This is document number D900000523, Version 1.1.

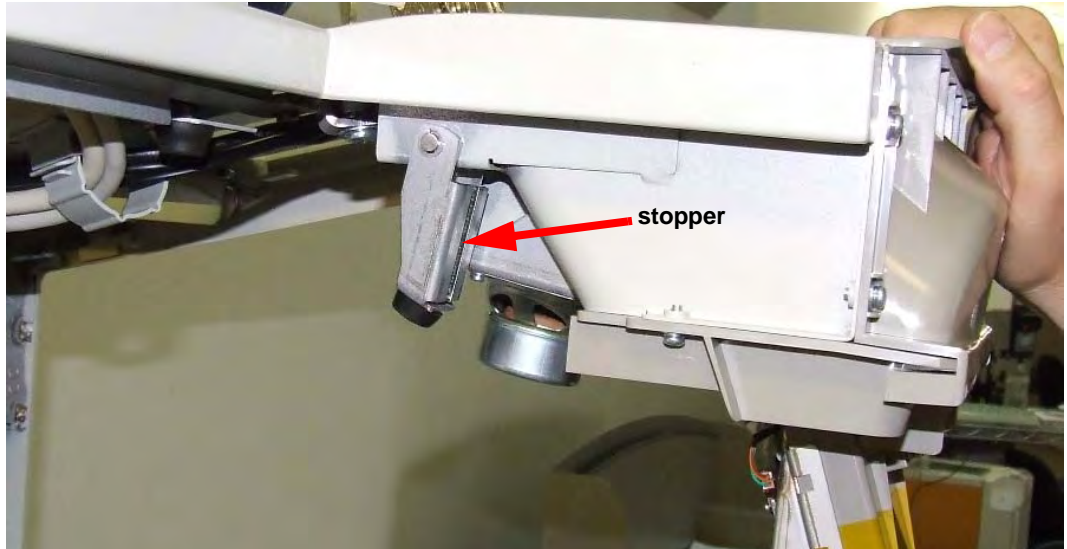
3. Check that the metal stopper and rubber foot are undamaged.

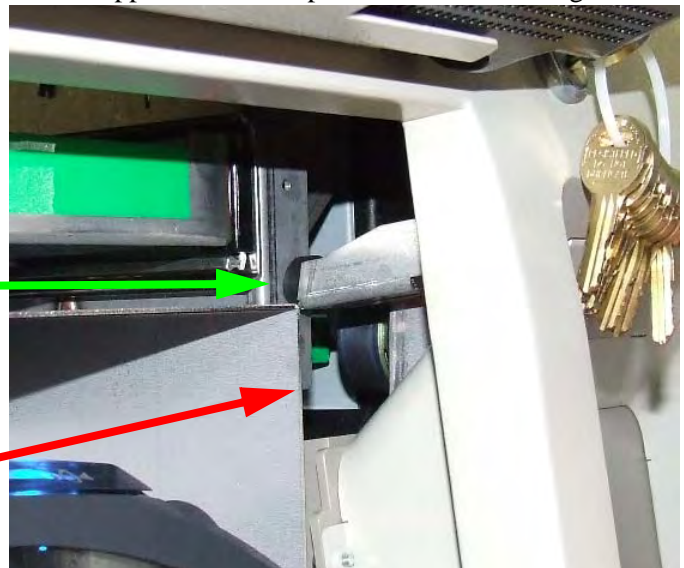
the stopper strikes the
(vertical) middle of the
casing frame flange

the stopper cannot
slip below the flange

9. Open and close the upper door a few times, ensuring that the stopper meets the casing frame flange in the center, and that the stopper does not slip down below the flange.
