## Subject: PowerVar UPS Firmware Update

During certain very short power fluctuations, the 500VA PowerVar UPS shipped in U-Scan Next Generation Robots can lock up. This is a very rare occurrence and has only been verified in 1 customer.

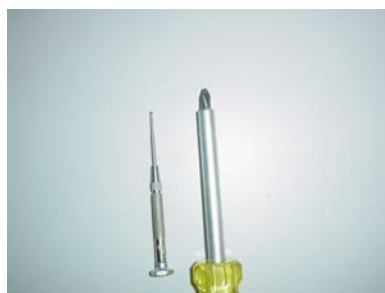
- Phillips Screwdriver
- Small Flat blade screwdriver or "Tweezer"

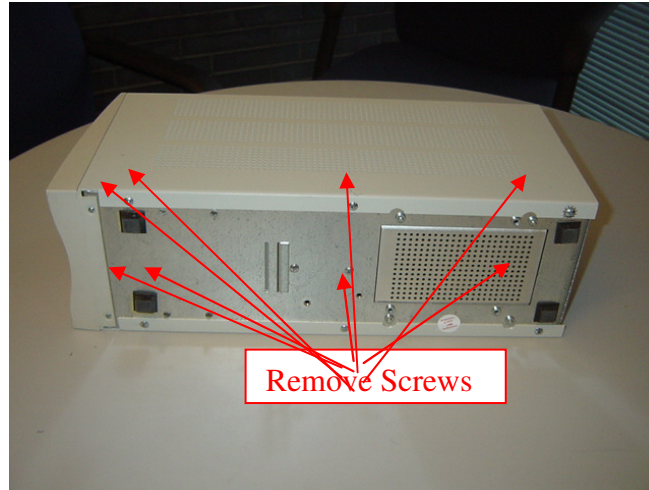
1. When ok to do so turn off the UPS by holding the ON / OFF button for 3 seconds. (blue button marked  $\text{\textcircled{O}}$ ). All LEDs on the front of the UPS should be off.
2. Remove all loads connected to the UPS by un-plugging them from the rear outlets.
3. Remove AC power to the UPS by removing the input power cord to the UPS.
4. Move the UPS to area where it is safe to work on and place the unit on its left side (looking at the unit from the front).
5. Remove the cover and front panel screws. Do this by removing the 8 screws (2 for the front panel and 6 for the cover.) located on the bottom of the unit. (save all the hardware as it will be reused).

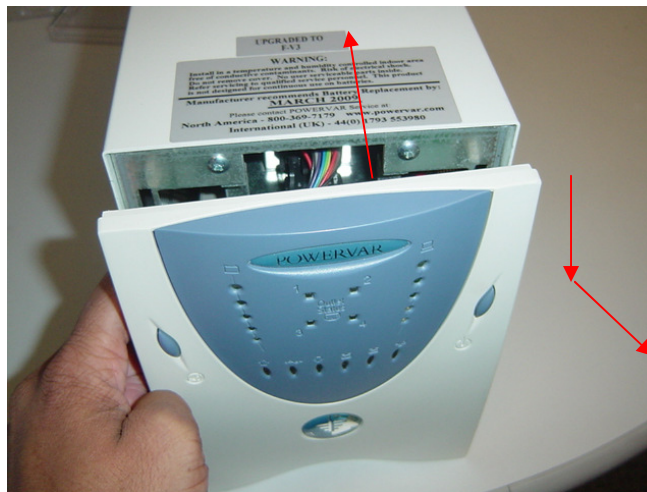
6. Turn the unit back on to its rubber feet. Then carefully remove the front panel by sliding the panel down and then out. (Note the front panel is attached to the PCB assembly).

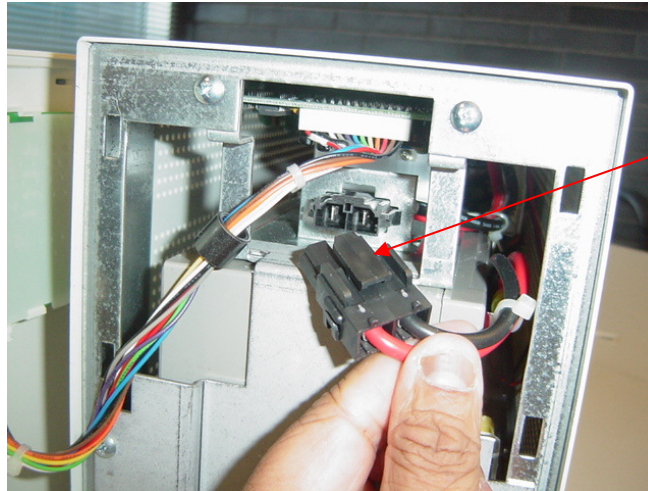
7. Disconnect the battery connector as shown. (The connector is locked in place. The top of the connector must be squeezed to unlock it).

Squeeze the lock tab to disconnect

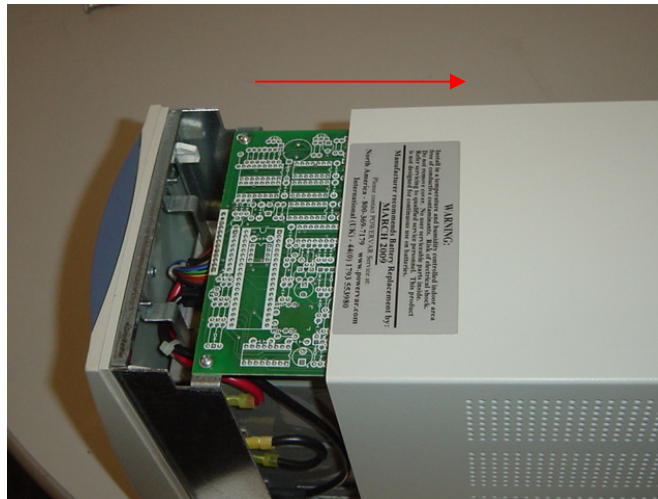
8. Remove the cover fully off of the UPS by sliding it to the rear of the unit. (Take care not to rub the cover against the PCB).

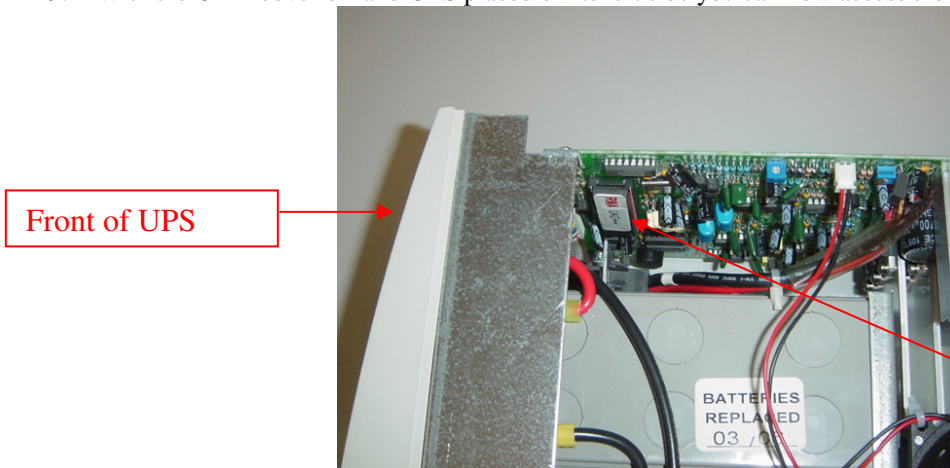
9. With the UPM cover off and UPS placed on its left side you can now access the EPROM.

Front of UPS

EPROM Location

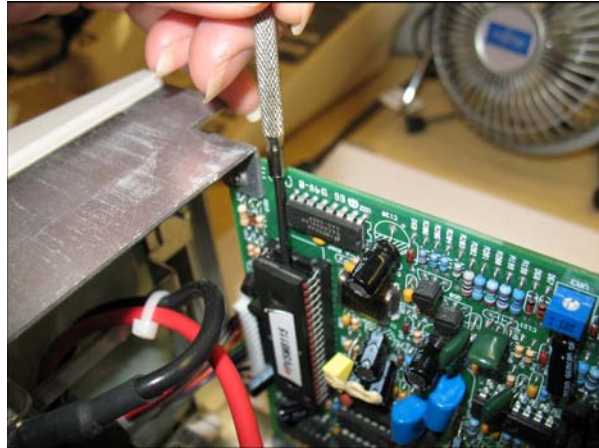
10. With the small flat blade screw driver or Tweezer carefully remove the old EPROM chip. (Take care as not to bend any pins or short-circuit other components. Take your time). See picture below.

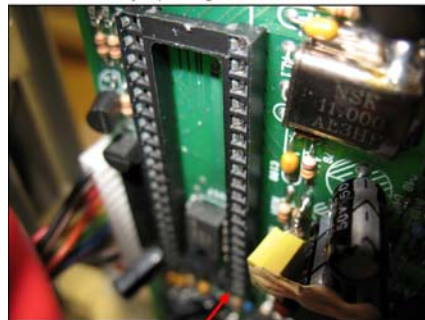
11. Install the new EPROM chip supplied in the replacement kit by aligning all pins very carefully then pressing firmly until all pins are in the socket tightly. **(IT IS IMPORTANT TO ALIGN PIN 1 OF THE CHIP WITH PIN 1 OF THE SOCKET)**. See picture for illustration.

Pin 1 on bottom

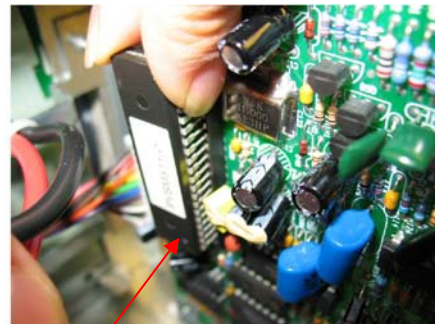
Pin 1

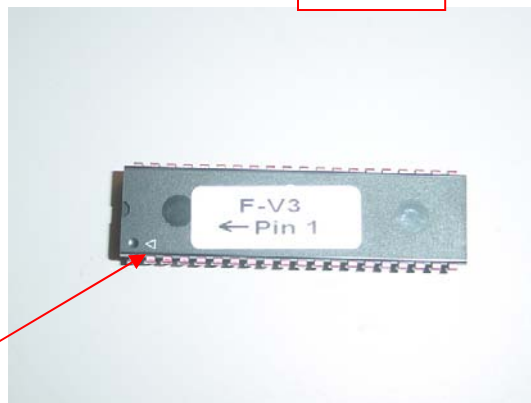
Pin 1 of the chip

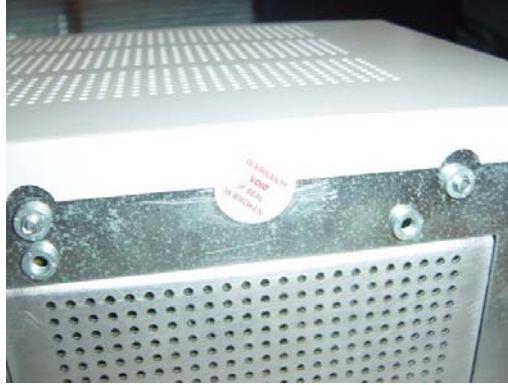
17. Place new “WARRANTY VOID IF SEAL IS BROKEN” sticker supplied in the replacement kit over the old sticker.

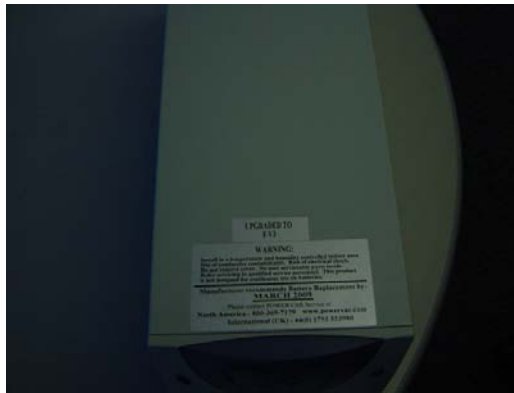
18. Turn the unit back over onto its rubber feet and place “UPGRADED TO F-V3” sticker supplied in the replacement kit on top of the cover as shown.

All updated units will have a label applied above the serial number label "UPGRADED TO F-V3", ref step 18 below.
