Subject: Genesis Coin Bin Breaking Speaker Magnet

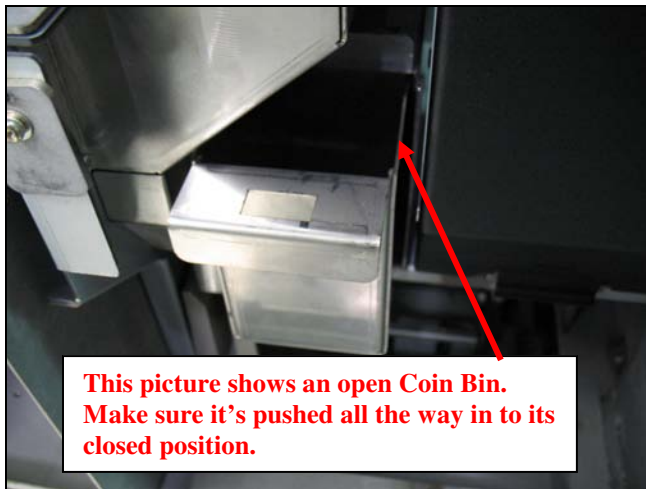
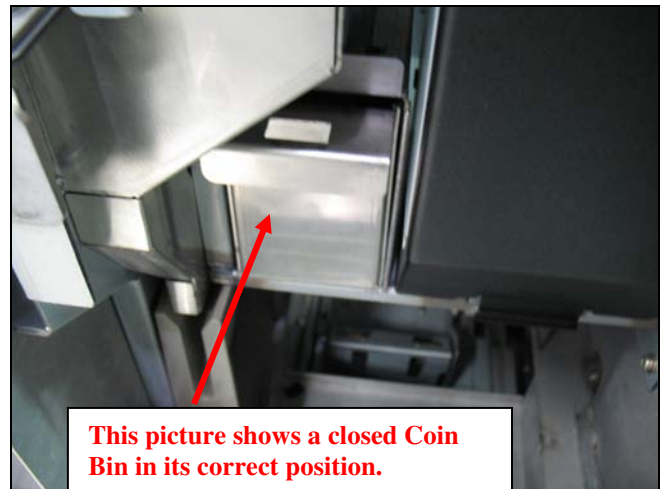
Genesis Front View

There have been some reports of the Speaker Magnet breaking off when closing or opening the Top Cover door on the Genesis. The Speaker Magnet can be caught if the Coin Bin is not fully inserted when closing or opening the Top Cover door.

To avoid breaking off the speaker's magnet, make sure the Coin Bin is fully pushed in to its closed position. Also make sure the rear clip that holds the Coin Bin in place is bent down enough to securely lock it in place when closed. If not, then bend the clip down enough to securely hold the Coin Bin in place while still allowing the operator to remove it.
