**Subject: Genesis Top Cover and Lower Door Rubber Cushions**

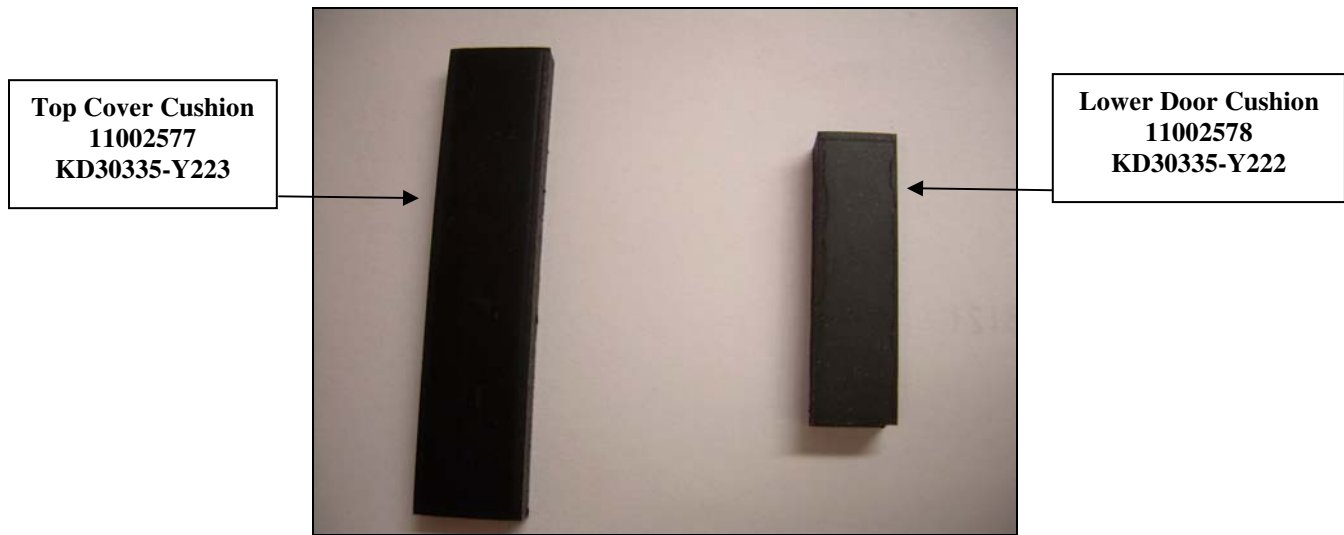
**Top Cover Cushion**      **11002577**      **KD30335-Y223**  
**Lower Door Cushion**    **11002578**      **KD30335-Y222**

The Cushions are now Spare Parts and can be ordered as needed.

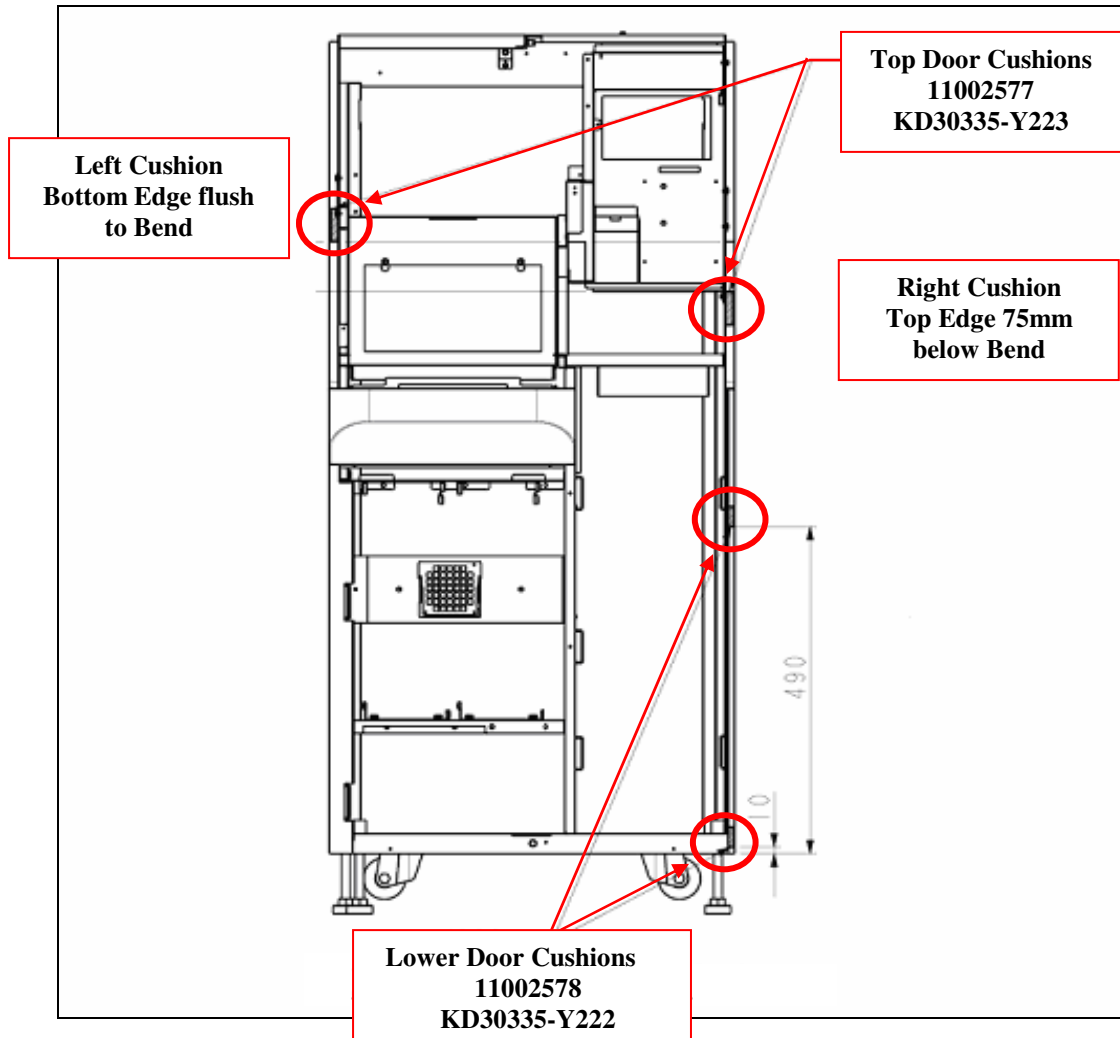
## Genesis Top and Lower Door Cushion Installation Instructions and locations

1. Clean Genesis surface with Isopropyl Alcohol or Acetone.
2. Allow surface to air dry for 2 minutes.
3. Peel and affix cushion to locations shown above.
4. Top Door Cushion: 11002577 KD30335-Y223
5. Lower Door Cushion: 11002578 KD30335-Y222
