**Subject: Genesis USB HUB Bracket Mount Changes**

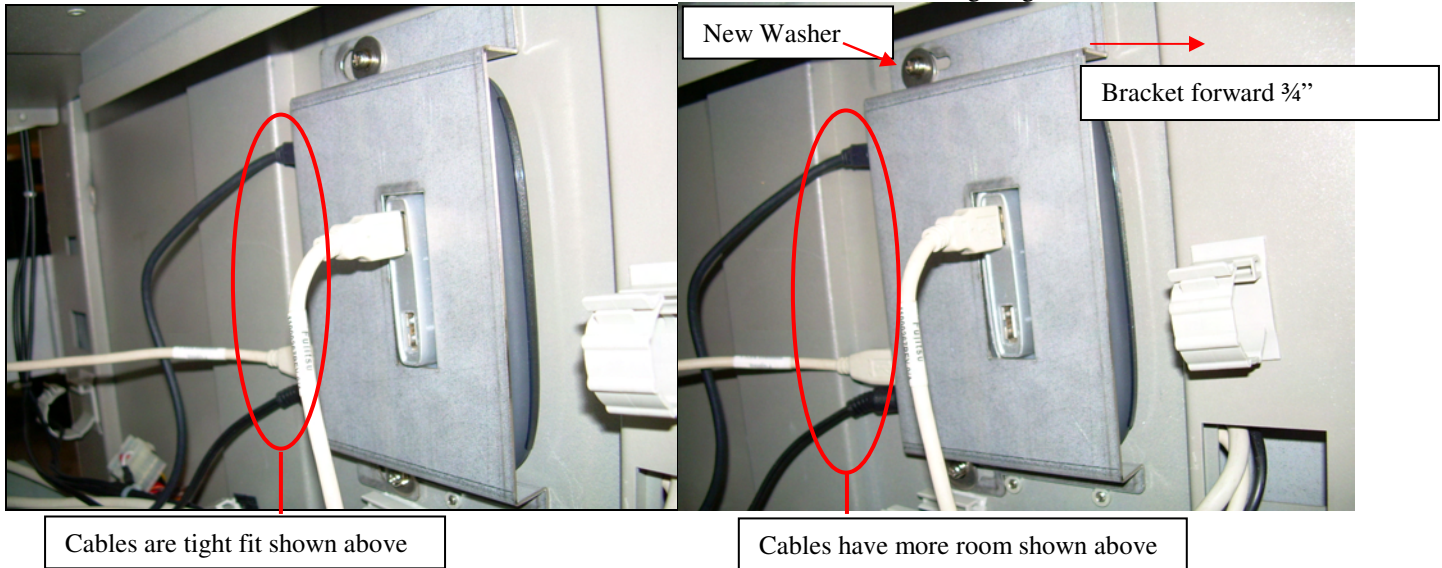
There have been some reports that on the Genesis USB HUB, the cable connectors that plug into it are getting stressed due to not enough room between the bracket and the brace. This was only in the first approx. 50-75 Genesis units built. Units after that have the Mounting Bracket mounted different.

The Illustration below shows USB Bracket all the way back.

The Illustration below shows the new washer and bracket mount slide forward 3/4", giving more room for cables.

For earlier units that have this close fit issue, a Flat Washer can be added to the USB HUB bracket. This allows the bracket to be adjusted forward about 3/4 of an inch which will relieve the stress on the cables and connectors.

1. Remove the USB HUB Bracket by removing the 2 Screws using a Short Phillips screw driver.
2. Re-install the bracket using the same screws with the new Washer (USA0301119).
3. Slide USB Bracket forward as much as possible and tighten screws.
4. Done.
