Subject: Genesis Cable Clamps Coming Off

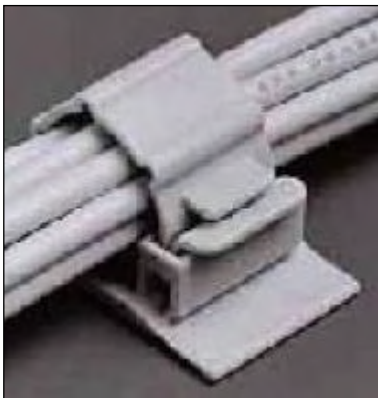
Large Adhesive Cable Clamp - 11001478

There are 2 types of adhesive cable clamps used (large and small) below are pictures to illustrate the differences.

Once a cable clamp adhesive comes loose, it cannot be re-used (will not have sufficient adhesion).

The location must be thoroughly cleaned with Alcohol or Acetone, and then the clamp must be secured and allowed to cure.

Cure time is specified as 24 hours from the supplier so the cable must be secured as to not put strain on the retainer for that period of time. Again it's very important to allow 24 hours of cure time or the clamp will not hold.

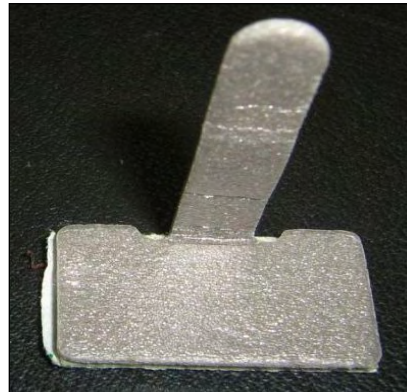
Small Adhesive Cable Clamp - 11001474

The small cable clamp was being received from an alternate supplier which had a weaker adhesive.
