Subject: Genesis Top Door Stopper Kit

Problem

If the Genesis Top Door is closed improperly (i.e. the door safety handle is not depressed prior to closing) and the operator attempts to close the door with excessive force, it can result in the Door Stopper bending and its rubber foot becoming stuck on the chassis frame. When trying to pry open / release the stuck door, the stopper bracket, rubber foot or top door can be damaged.

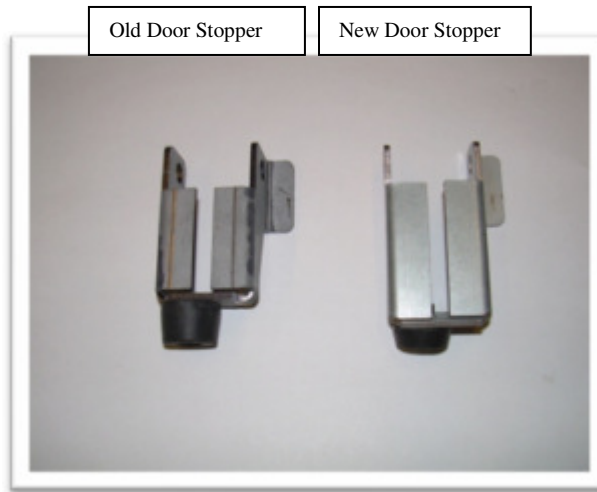
Photo A
(Left Hand versions shown)

- **Part Comparison:**

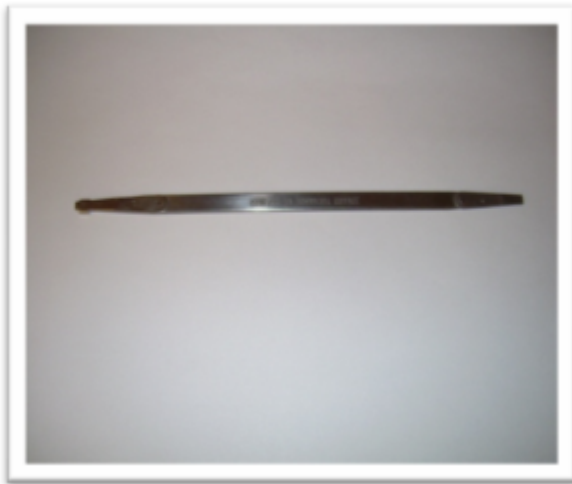
Photo B
“C” Clip Removal Tool
Mouser Part #CS-1022 or equivalent

- **Tools Required**
