Subject: Genesis Site Prep Error

An error has been found in the U-Scan Genesis Site Prep manual that may lead installers to improperly install units.

V06_Genesis_SitePrep.pdf

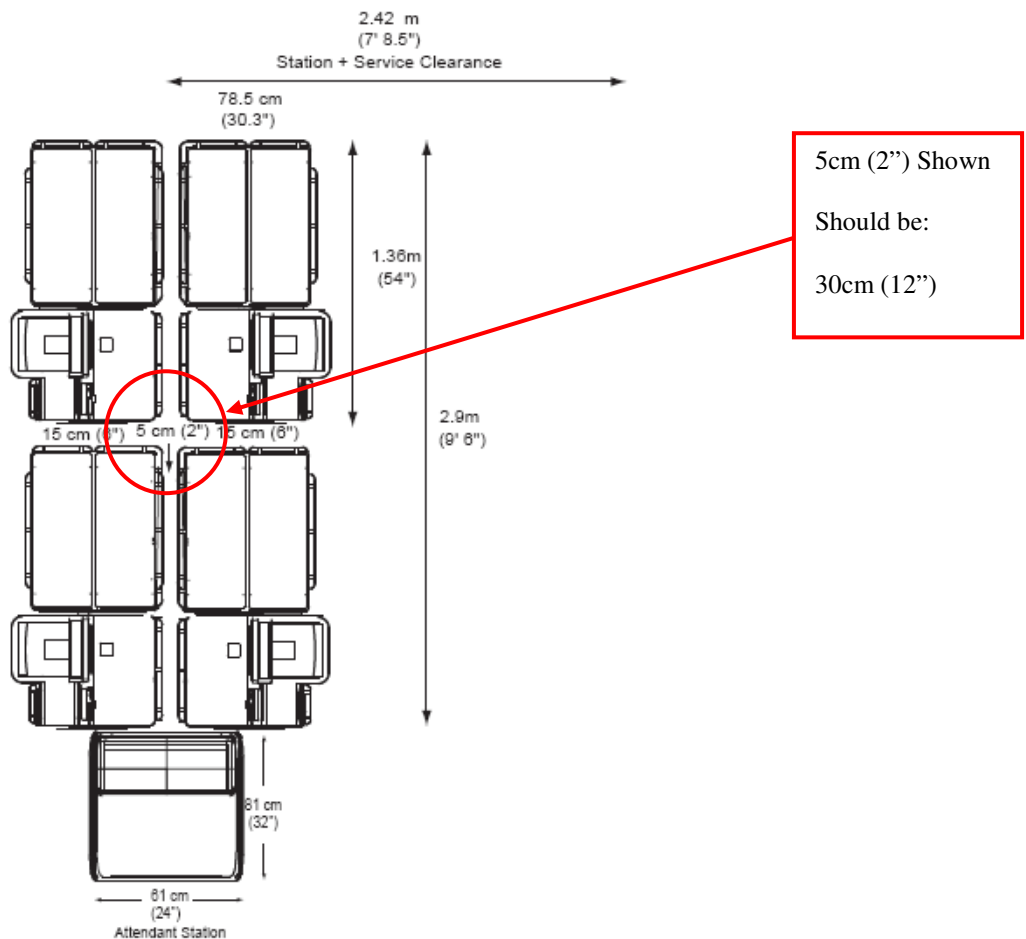
The illustration (see below), indicates that Genesis Robots installed back to back only need 5cm (2 inches) service clearance between rows. This is not correct. The correct dimension is 30cm (12 inches).

Figure 2.3 Four U-Scan4 Customer Stations with Attendant Station (C)

This change will be made in a future revision of the document (no anticipated data at this point).
