Subject: D22/D25 Stacked Display Mount Arm

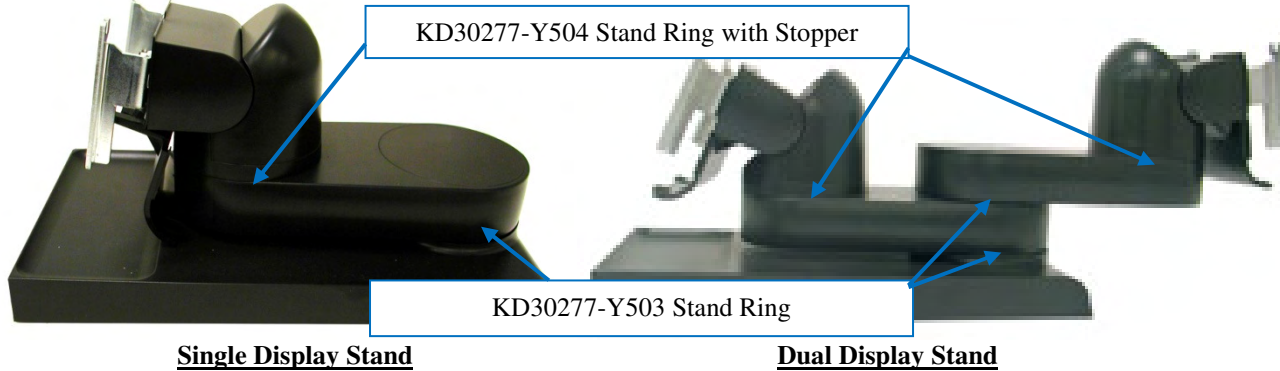
There have been reports of the Stacked Display Mount Arm Pivots are coming loose in the field. This report is most prevalent on units where the display is repositions frequently by the operator. This Display Mount is when the D22/D25 display(s) is stacked on the TeamPoS 3000 or TeamPoS 3600 terminal.

During production, the internal mounting screws were not being tightened to the proper torque setting (5.2 in/lbs, 6.0 cm/kg). If the display position is moved frequently, this could result in the Display Support Arms coming loose, screws coming out, and screws or retainer rings breaking. This has been corrected at manufacturing. There are other improvements being investigated for manufacturing, however these will not impact the field or installed units.

Inspect each of the pivot areas of the display arm.

If either of the pivot rings is broken or screws missing, replace as needed, see part numbers below.

Remove the retaining screws (2 at a time), apply a small drop of Loctite to the threads of each and re-install.

If you have a torque screwdriver, tighten the screws to 5.2 in/lbs (6.0 cm/kg).

If you do not have a torque screwdriver, Tighten all 4 screws with a #2 Phillips until finger snug, then tighten each another 1/4 turn. Test each screw again. You should not be able to get any additional movement without extreme force.
