Subject: Genesis Door Alignments and PM Parts

Genesis Door Alignment Upgrade

This is document number D900000503, Version 1.0.

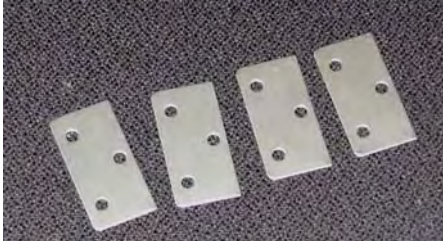
1. To correct a slight mis-alignment, install an appropriate number of supplied shims (11004313) behind the lower hinge to tilt the door upwards.

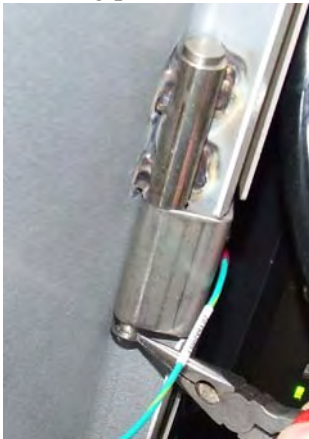
2. Unlock and open the lower door of the station. Before installing the shims, remove the bottom hinge pin:
 - a. Using pliers, remove the retaining ring at the bottom of the pin.

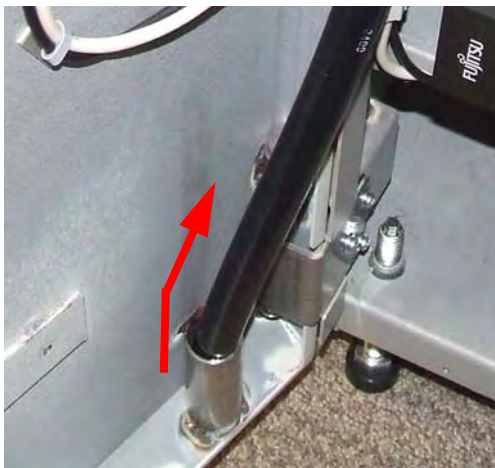
- b. Pull the pin up and off.
3. Move the drain hose out of the way. Pull the hose up and out of its connector on the bottom of the door.

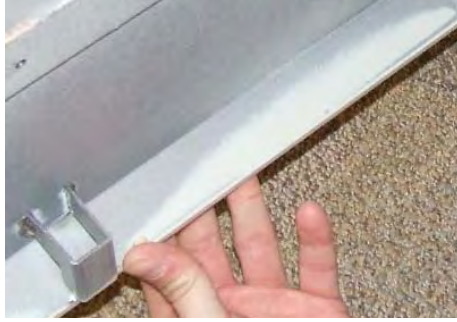
4. While supporting the door to relieve strain on the screws, remove the three screws that secure the hinge to the casing.

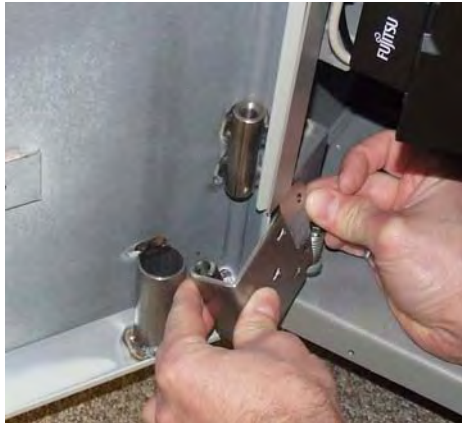
5. Install the shims behind the hinge.

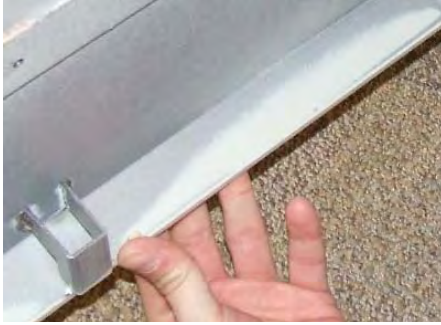
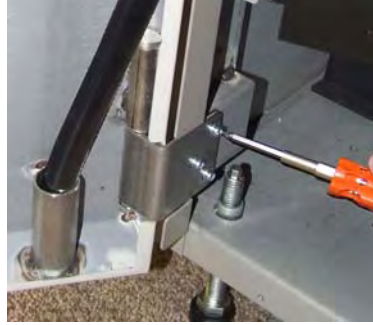
9. Adjust the door upward and tighten the screws. While tightening the screws, test the door alignment (check that the door closes and locks properly). If you removed the drain hose earlier, be sure to re-install it in the door.

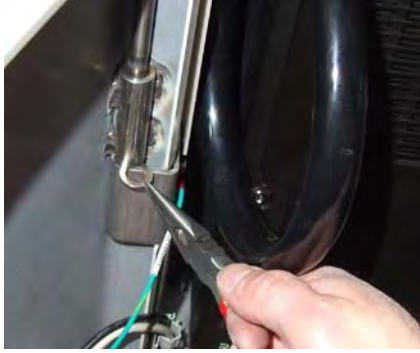
4. Pull the pin up, then insert the washer(s) so that the pin will pass through the washer(s) when it is lowered back into the hinge.

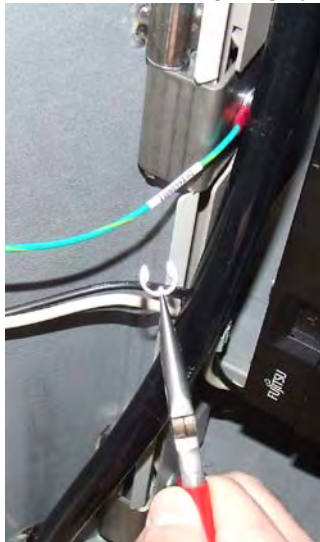
5. Test the door alignment (check that the door closes and locks properly).
6. Re-insert the retaining rings you removed earlier.

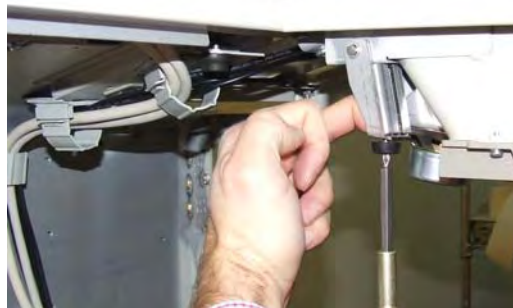
- b. Install the foot. Apply Loctite to the screw and secure the assembly in place.

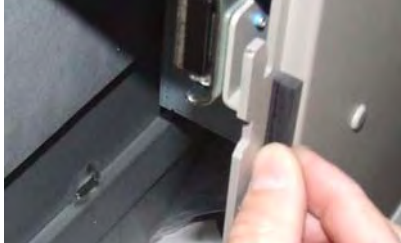
1. Unlock and open the lower door of the station.
2. Clean the surfaces with an alcohol wipe and let dry before applying the rubber cushions. Be sure to remove any residual adhesive.

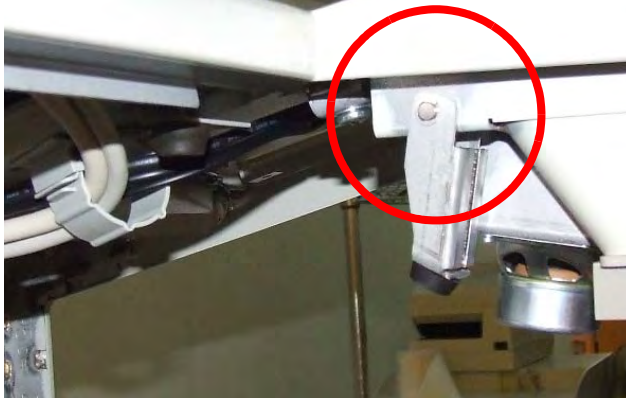
3. Lubricate the top cover release mechanism (foot bracket pin).

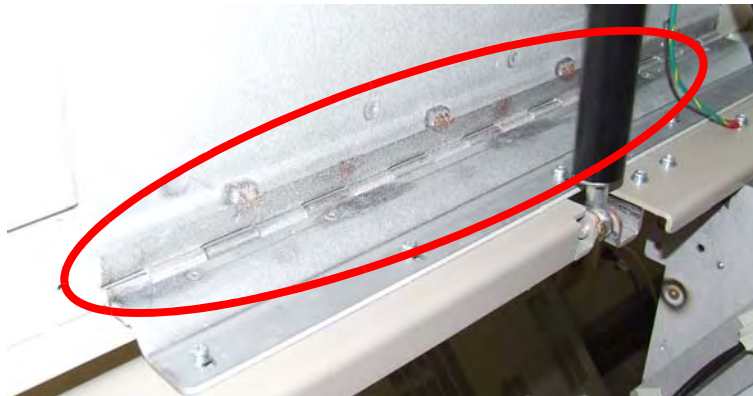
4. Lubricate the main hinge.

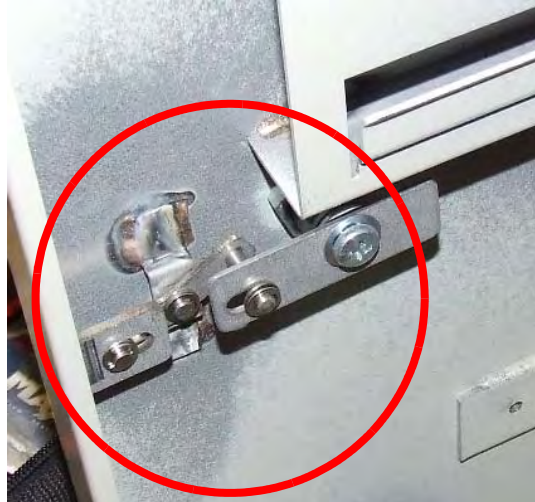
3. To access the lower door lock mechanism, remove the coupon box.
4. Lubricate the lower door lock mechanism.

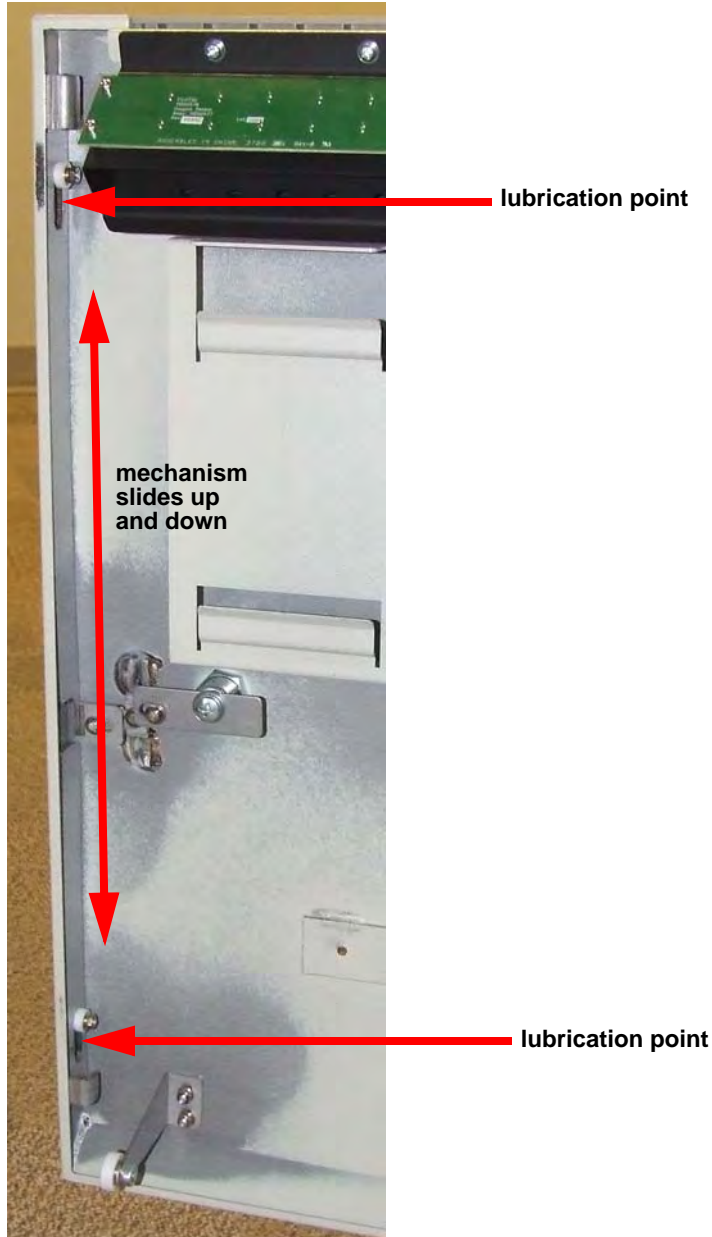
5. Lubricate the lower door's vertical locking mechanism (bar).
