Subject: F53 Cassette Locking Tabs Bending

Fujitsu Frontech NA	PRODUCT SUPPORT BULLETIN	PSB-09-008
	Sustaining Engineering		OHIR418
	San Diego, CA; Montreal, QC		April 24, 2009

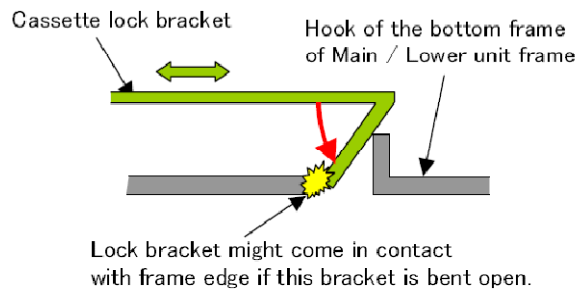
If the tab gets bent slightly, it will then catch on the metal base of the F53 Main Unit which bends the tab even further. This makes the cassette difficult to insert, can make it difficult to release and remove, and can also cause the Cassette to make a grinding noise when operated.

Replace Metal Locking Tab with stronger version.

- KD02881-E531 Cassette Locking Metal Tab (rev 10).
- This change was cut into Cassette production: Rev 10F or above, cassette serial #KA00045793.
- The Locking Tab part number did not change, all future orders of this part will be the new revision.
- The only visible difference is the new Tab is Thicker/Heavier metal (1.5mm instead of previous 1mm thick).

Install Mylar film to protect cut out in F53 Main Unit.

- KD02881-Y034 Mylar Film
- This change was cut into F53 production: Rev 02B or above.
- See illustrations under Installation Instructions below.
