**Subject: Genesis Bill Acceptor Hinge**

# Bill Acceptor Hinge Replacement

This is document number D900000512, Version 1.0.

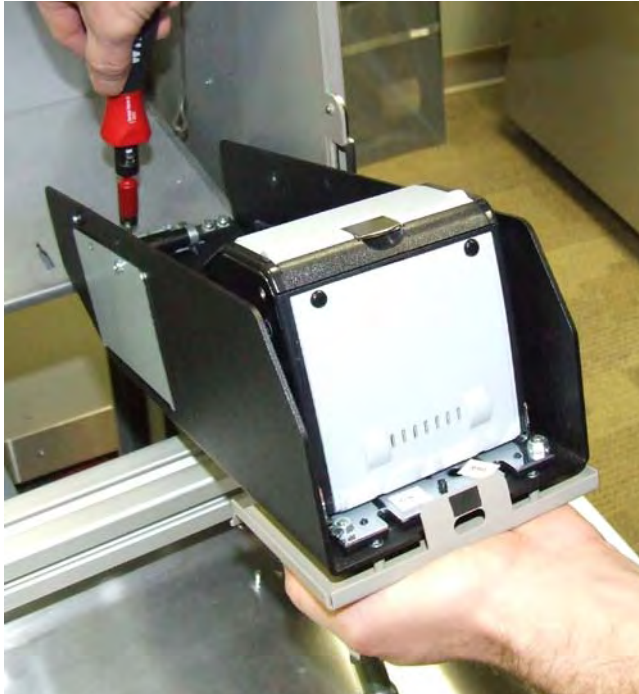
After extensive testing of various scenarios (in both lab and field), it has been found this is a ‘compounding’ issue. The hinge breaking is caused by the hinge mounting screws coming loose putting excess stress on the hinge itself. The screws coming loose is caused because during production and subsequent field replacement, the hinge mounting screws are not being properly torqued and the screws used did not have a locking compound.

7. Hold the Bill Acceptor bracket up slightly to reduce pressure on the connection and use an Allen key to remove the two M4 screws that secure the bracket hinge to the shelf of the Customer Station casing.

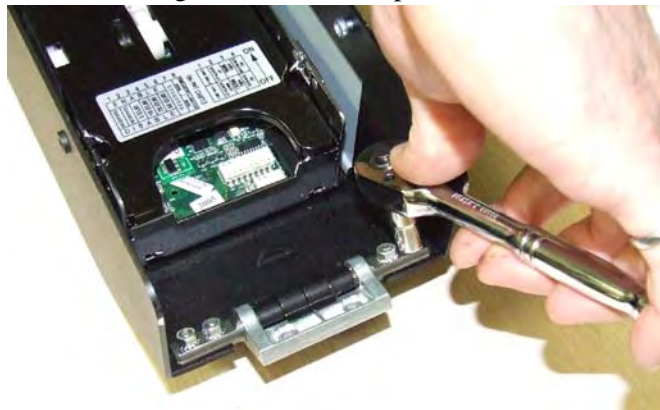
**Important:** Carefully inspect the existing hinge for cracks or other apparent damage. Always replace a damaged hinge with the new hinge and hardware supplied in kit 11001216F10.

3. Assemble the hinge onto the Bill Acceptor bracket, oriented as shown in the photograph shown below.
4. Secure the hinge to the Bill Acceptor bracket with the four supplied M4 nuts.
