Subject: Genesis Top Door Stopper Spacer

Upper Door Stopper Upgrade

This is document number D900000523, Version 1.1.

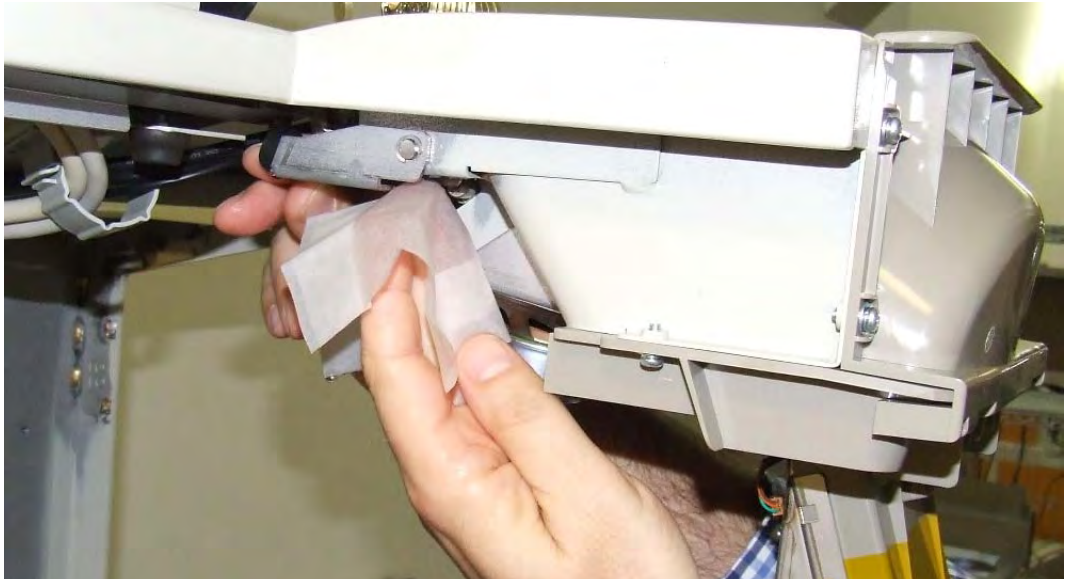
4. If necessary, wipe the upper door frame above the stopper with an alcohol wipe (11002506) and allow the alcohol to evaporate.

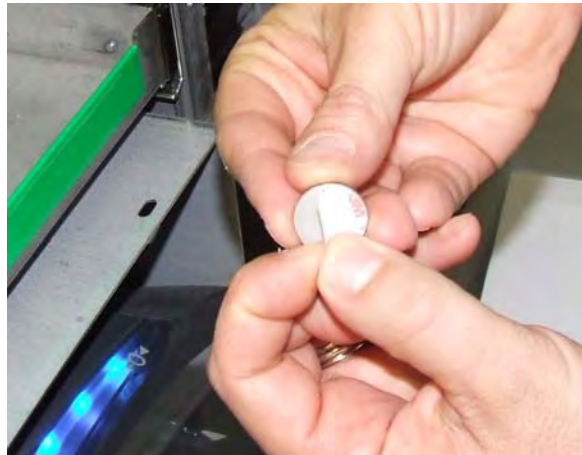
5. Peel off the paper backing on the round spacer (11004612).

6. Stick the round spacer on the upper door frame flange so that it is centered from left to right, and positioned at the bottom edge.
