CASHCODE Bill Acceptor Service Guide for U-Scan

ST, SM, and MSM Models

**Version: North American Version
Document Update number: V5
Date: January 19, 2006**

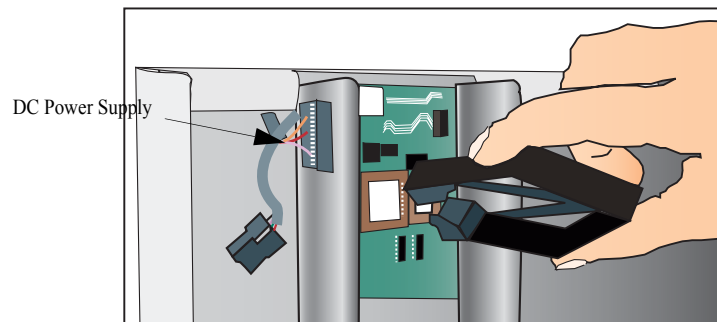
- 1 Disconnect the DC power supply from the side of the Bill Acceptor.
- 2 Remove the CASHCODE vault.
- 3 Remove the back plate to uncover the circuit board.
- 4 Remove the *smaller* chip. (See the diagram below.)
