**Subject: U-Scan CashCode Bill Acceptor – New Firmware (Canada)**

## Procedure to Update Firmware on CashCode SM Bill Acceptors (Canada)

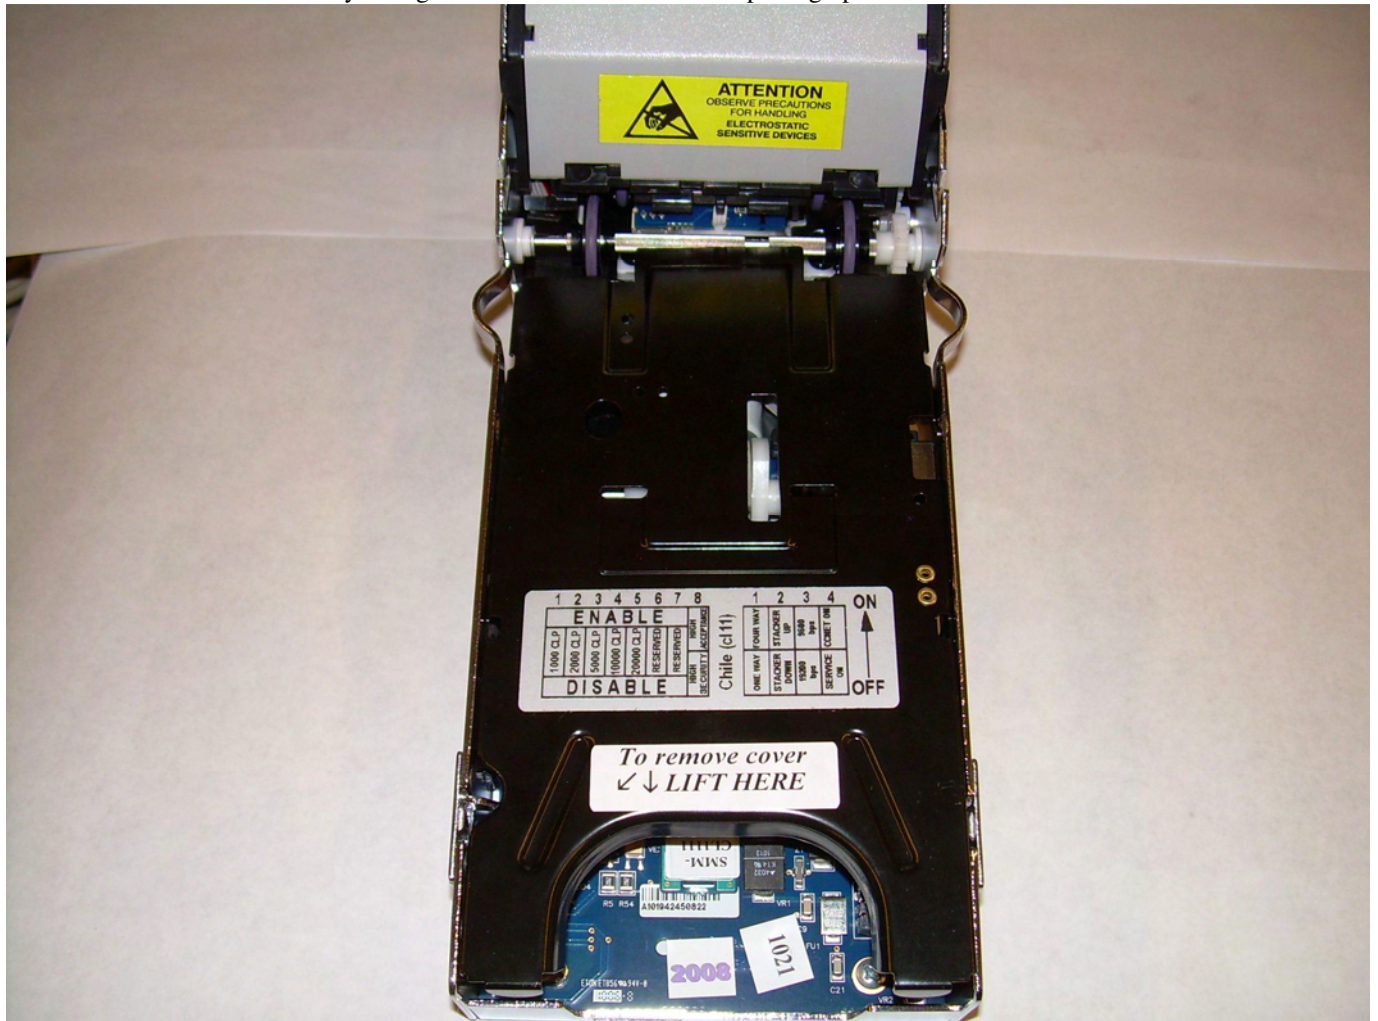
1. Power off unit.
2. Remove Validator cover by lifting the left side of the cover and pulling upward.

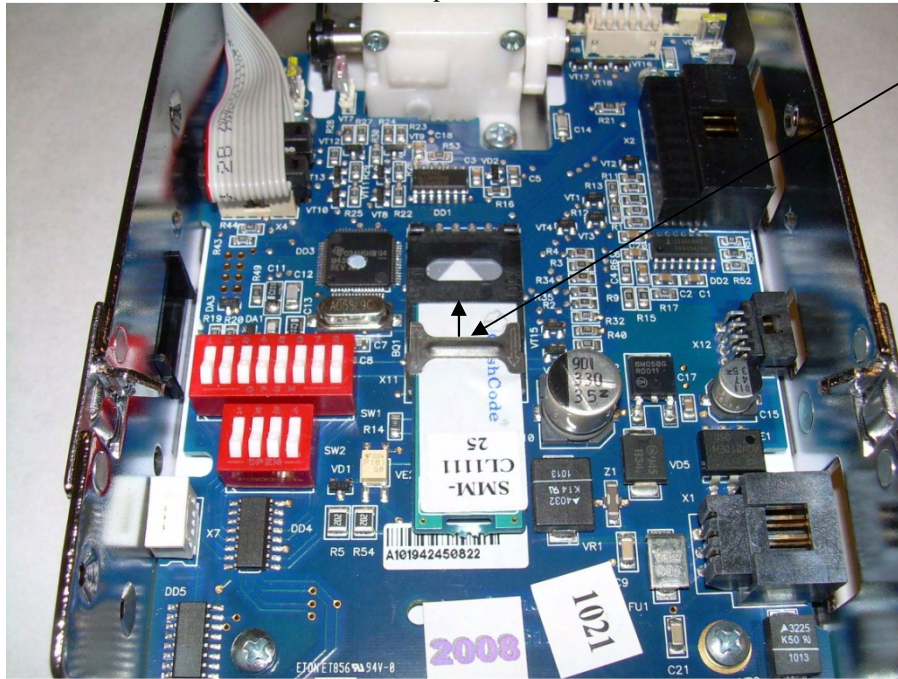
3. With the Validator cover removed from the unit, remove current memory stick by sliding the metal clip toward the plastic socket.

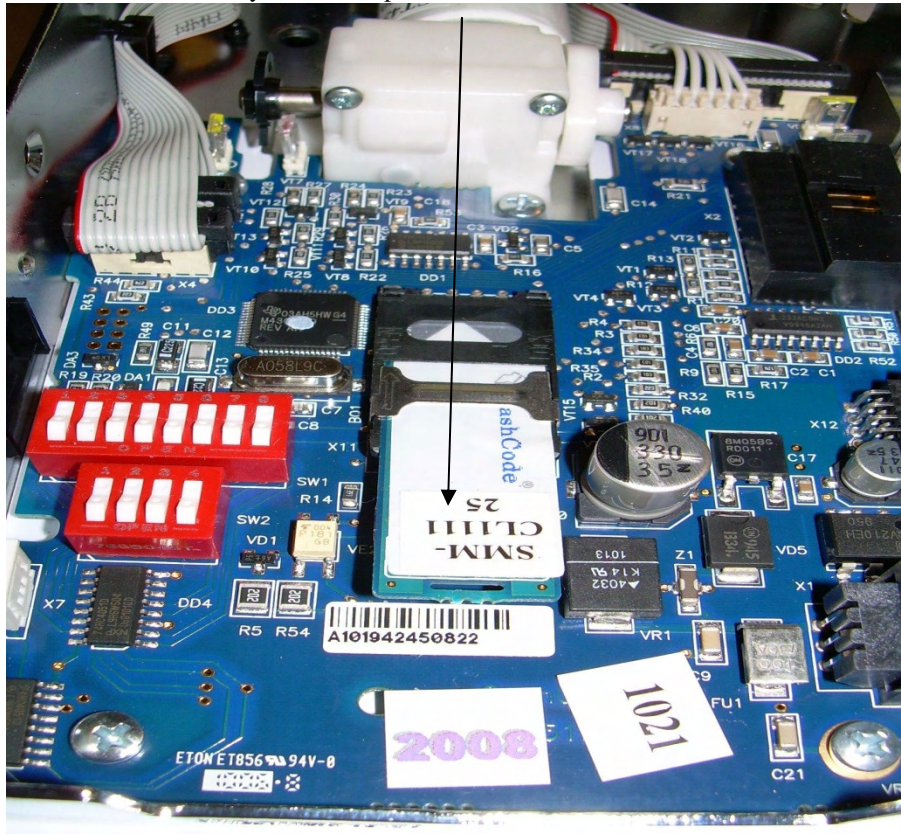
4. Once the slide releases the memory stick, lift up and slide out from the connector.

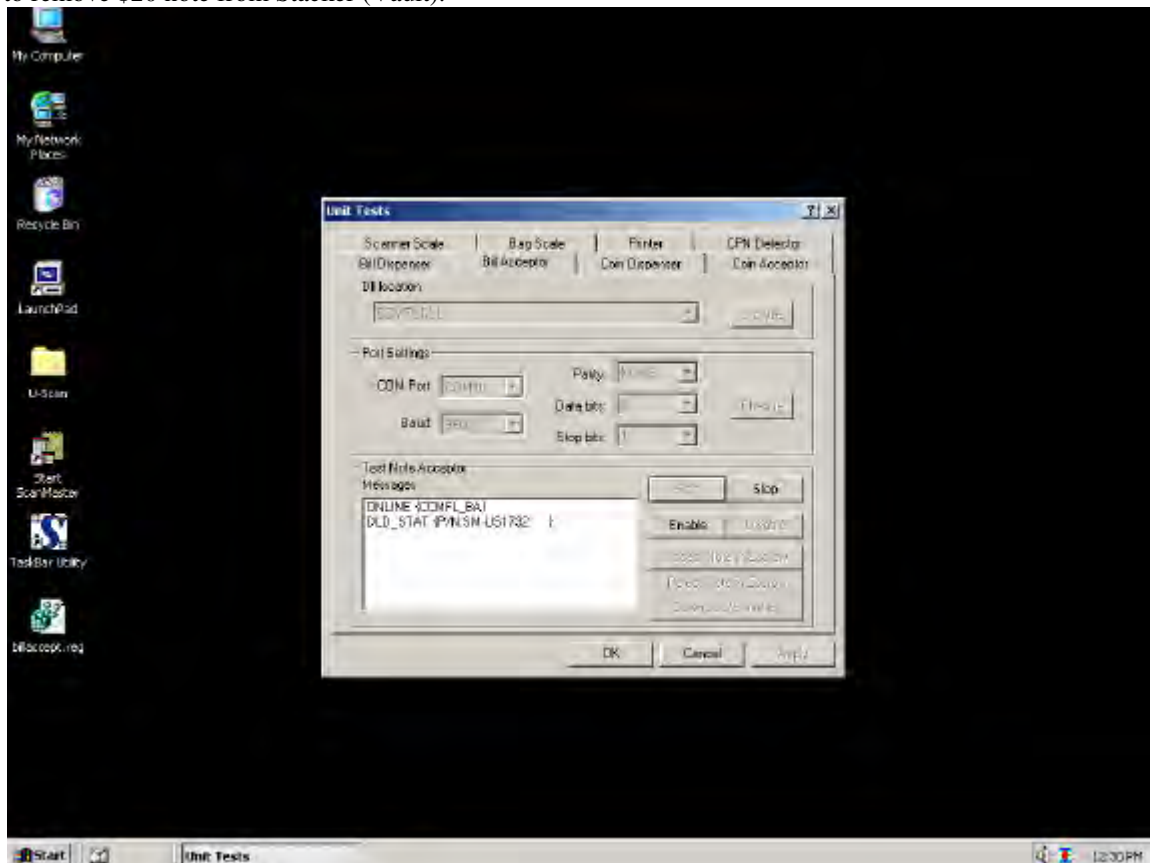
12. Press Apply.
13. Press START and Press ENABLE. Insert \$20 Canadian note to test. Press OK on device tester screen and remember to remove \$20 note from Stacker (Vault).

8. Power-up the unit and test.
9. From LaunchPad select DEVICE TESTER and enter 1379 and Press OK.
10. Select Bill Acceptor Tab and change CASHCODE.DLL to CCMFL.DLL by holding down SHIFT-KEY and PRESS \* (asterisk on #8 key). Select CHANGE button and select CCMFL.DLL from drop down list.

11. Set the following:  
**Com Port = 10 (or what ever port the device is connected to)**  
**Baud= 9600**  
**Parity=NONE**  
**Data Bits=8**  
**Stop Bits=1**
