Subject: U-Scan CashCode Bill Acceptor – New Firmware (Canada)

Procedure to Update Firmware on CashCode SM Bill Acceptors (Canada)

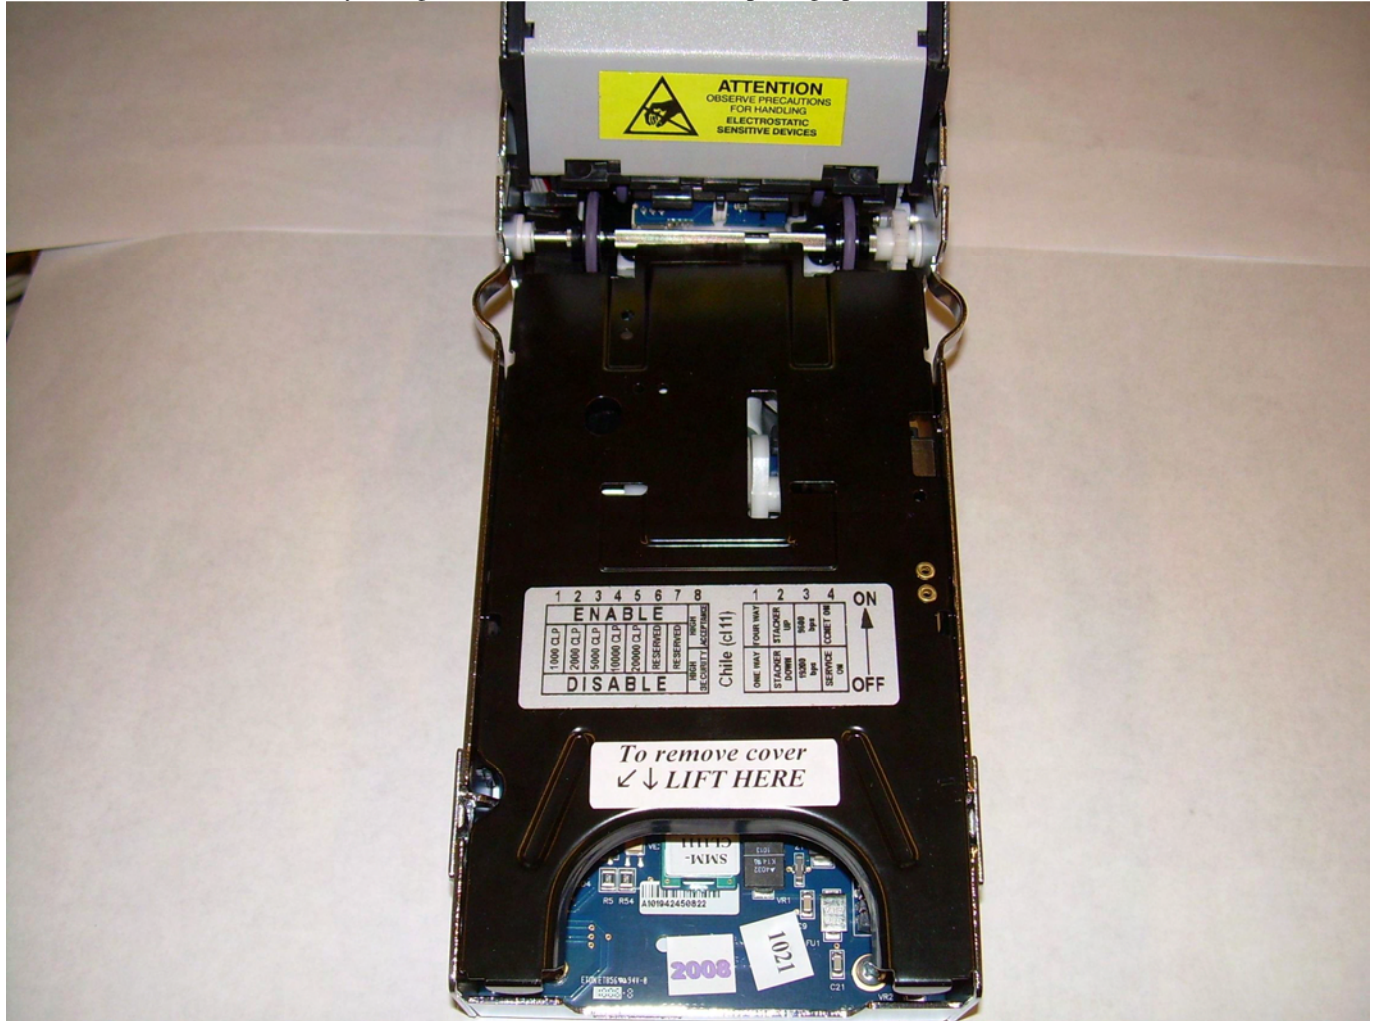
1. Power off unit.
2. Remove Validator cover by lifting the left side of the cover and pulling upward.

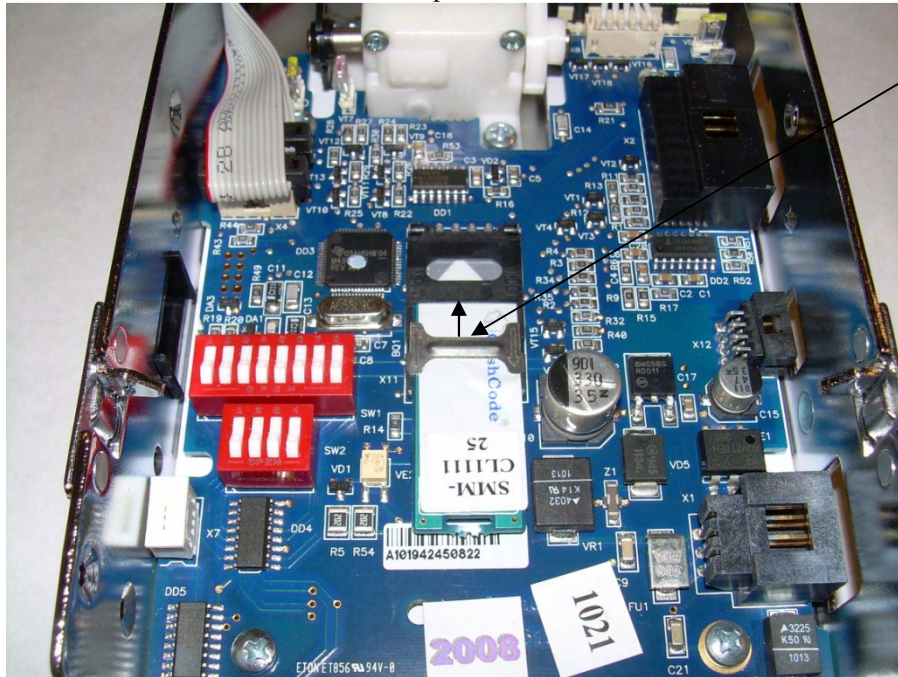
- With the Validator cover removed from the unit, remove current memory stick by sliding the metal clip toward the plastic socket.

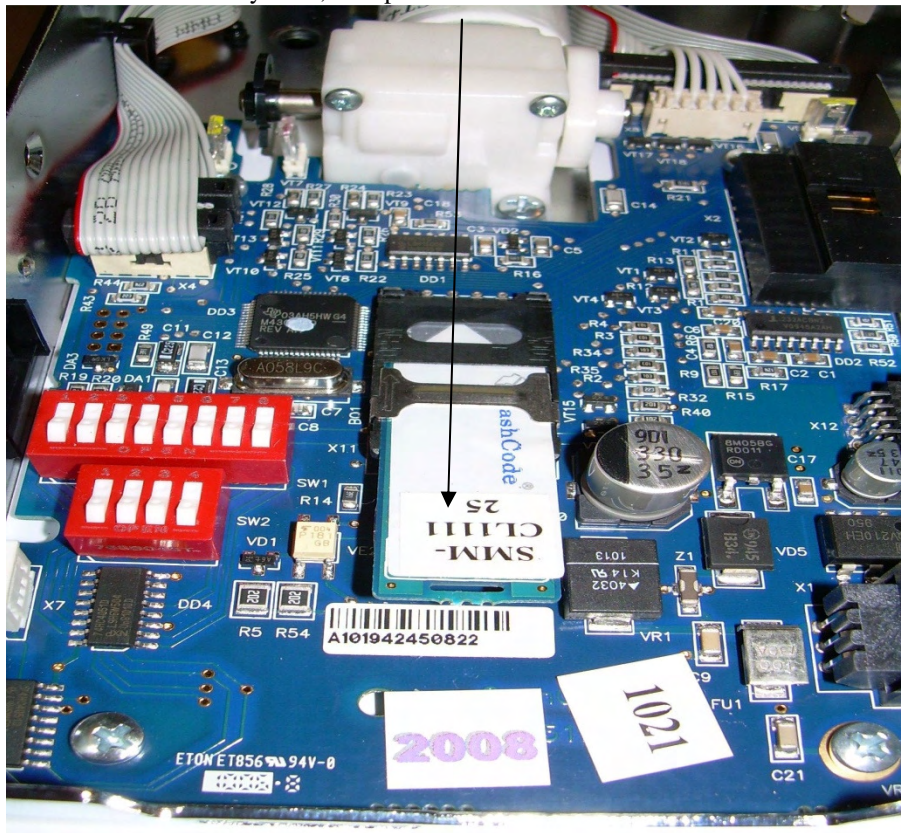
- Once the slide releases the memory stick, lift up and slide out from the connector.

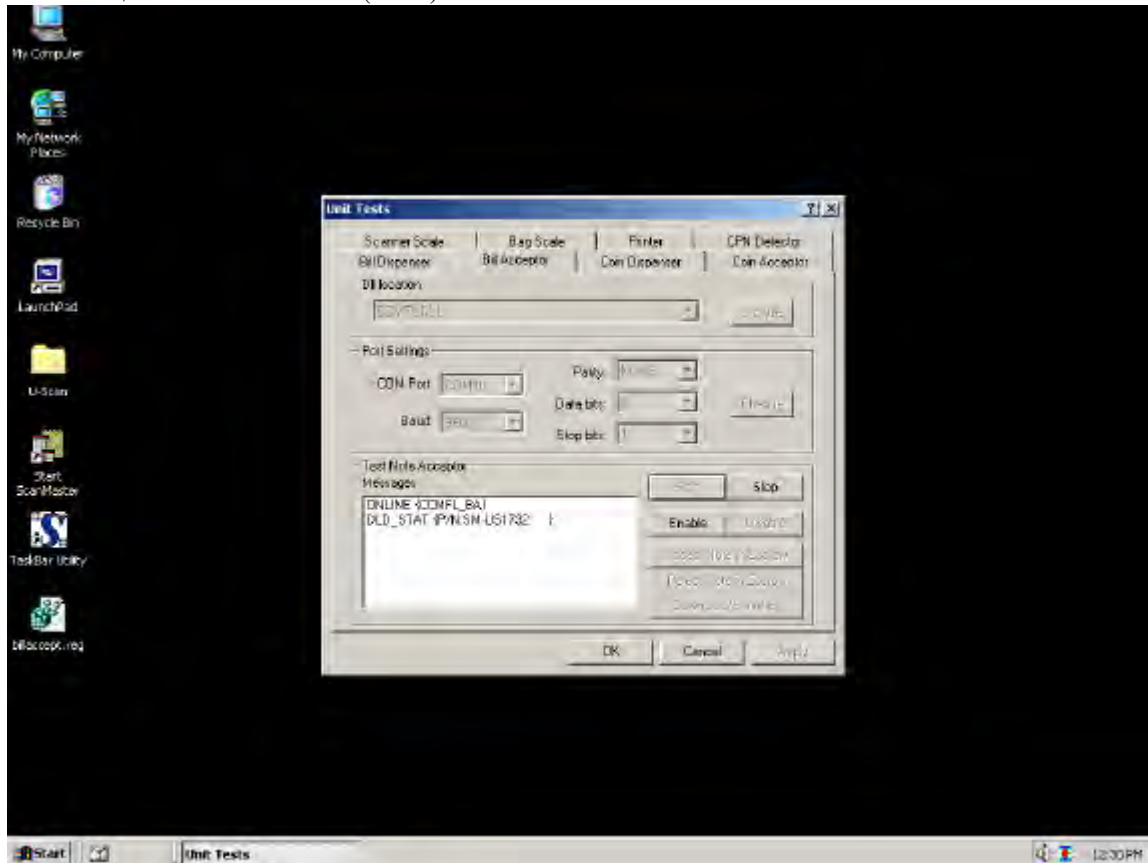
7. When lights stop flashing, power off the unit, replace the CA1521 memory stick with the original memory stick using the same steps 4 and 5 above.
8. Power-up the unit and test.
9. From LaunchPad select DEVICE TESTER and enter 1379 and Press OK.
10. Select Bill Acceptor Tab and change CASHCODE.DLL to CCMFL.DLL by holding down SHIFT-KEY and PRESS * (asterisk on #8 key). Select CHANGE button and select CCMFL.DLL from drop down list.
11. Set the following:
Com Port = 10 (or what ever port the device is connected to)
Baud= 9600
Parity=NONE
Data Bits=8
Stop Bits=1
12. Press Apply.
13. Press START and Press ENABLE. Insert \$50 Canadian note to test. Press OK on device tester screen and remember to remove \$50 note from Stacker (Vault).
