Subject: U-Scan CashCode Bill Acceptor – New Firmware (for Canada \$20)

Procedure to Update Firmware on CashCode SM Bill Acceptors (Canada)

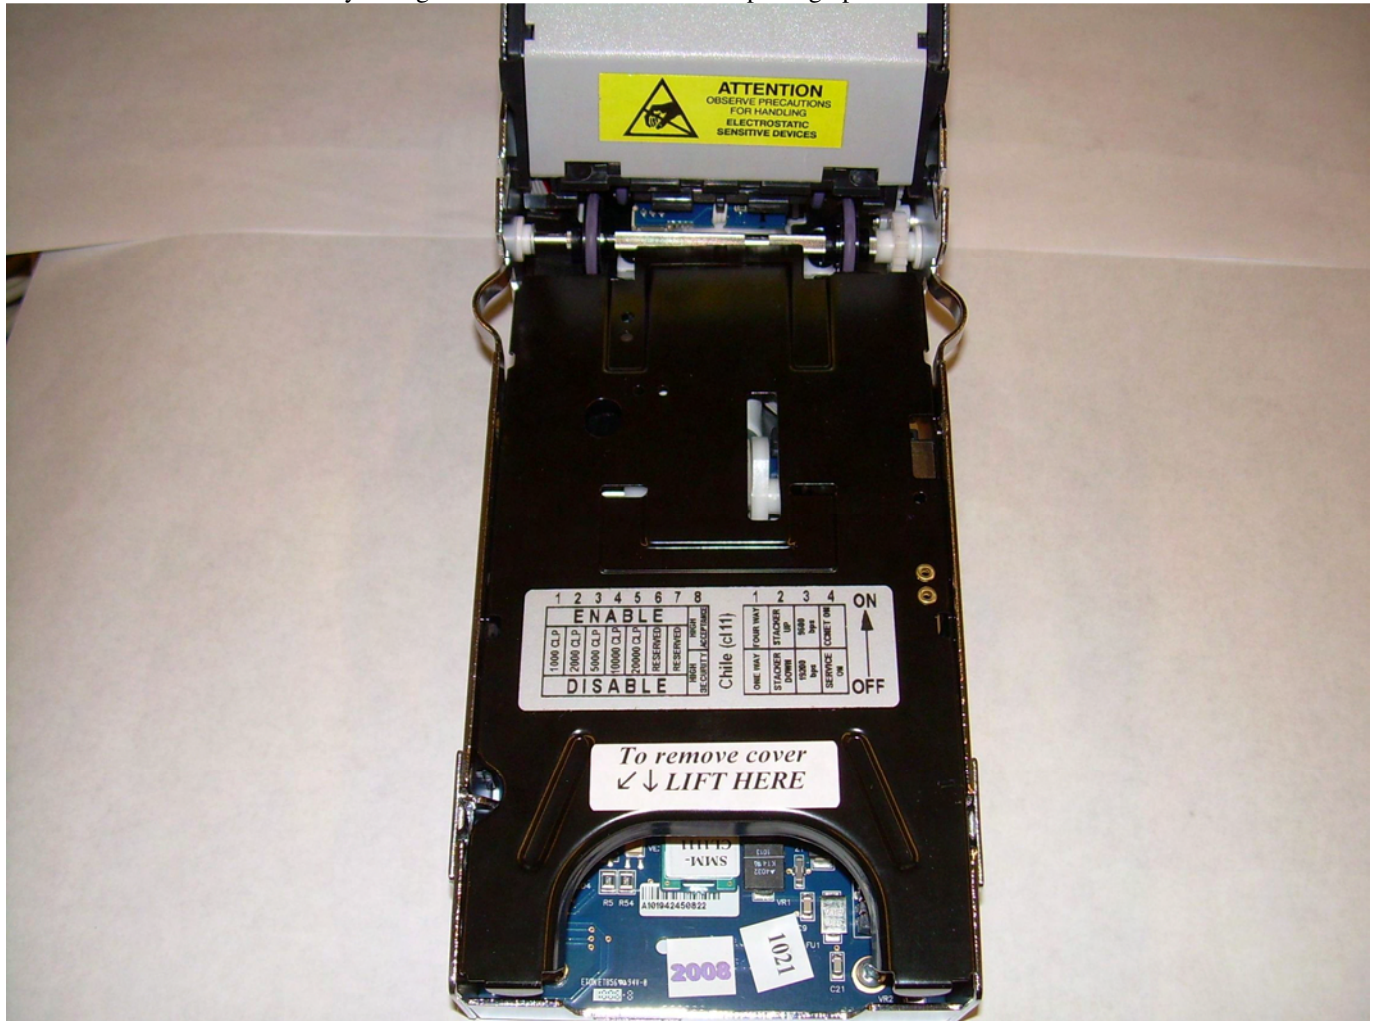
1. Power off unit.
2. Remove Validator cover by lifting the left side of the cover and pulling upward.

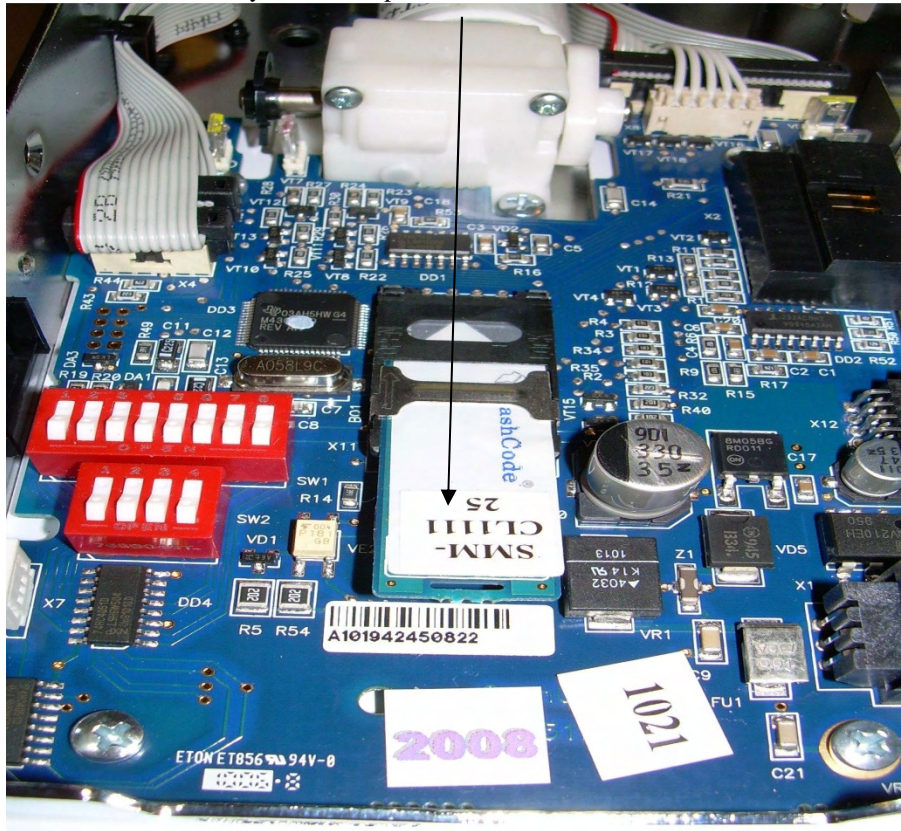
- Once the slide releases the memory stick, lift up and slide out from the connector.

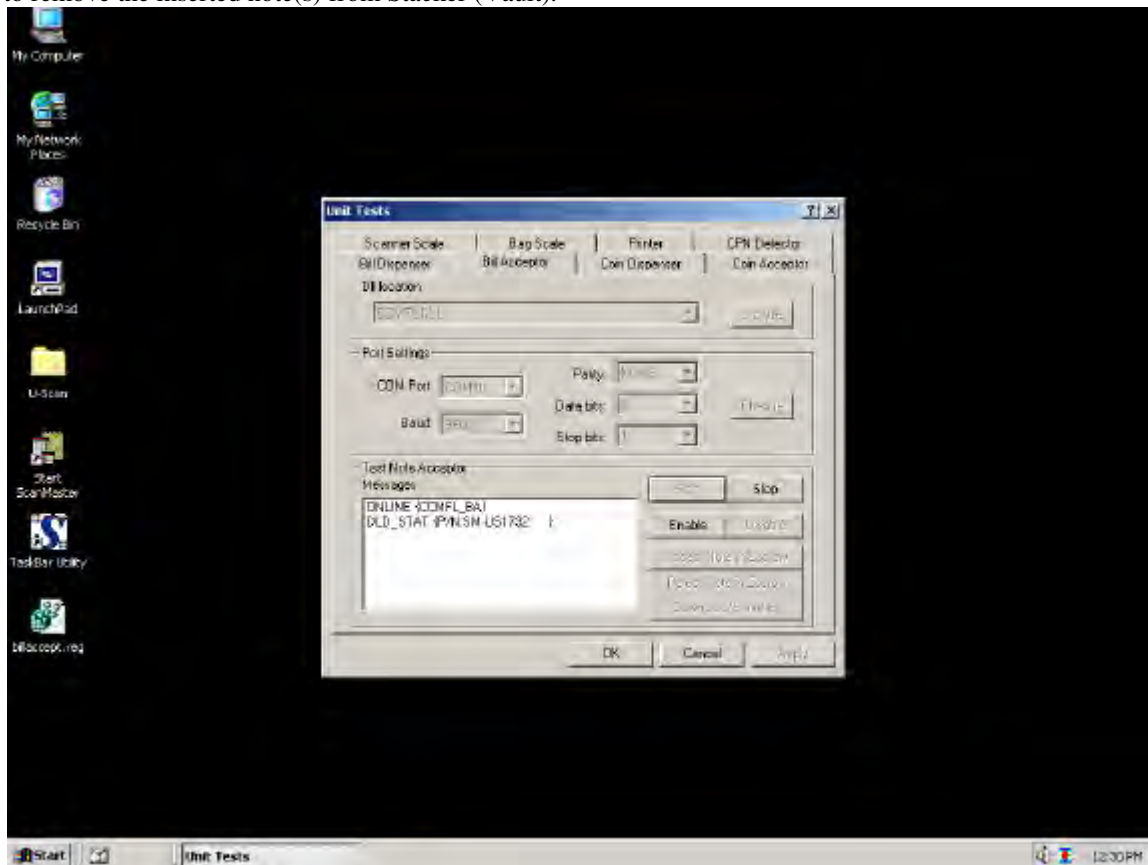
7. When lights stop flashing, power off the unit, replace the CA1522 memory stick with the original memory stick using the same steps 4 and 5 above.
8. Power-up the unit and test.
9. From LaunchPad select DEVICE TESTER and enter 1379 and Press OK.
10. Select Bill Acceptor Tab and change CASHCODE.DLL to CCMFL.DLL by holding down SHIFT-KEY and PRESS * (asterisk on #8 key). Select CHANGE button and select CCMFL.DLL from drop down list.
11. Set the following:
Com Port = 10 (or what ever port the device is connected to)
Baud= 9600
Parity=NONE
Data Bits=8
Stop Bits=1
12. Press Apply.
13. Press START and Press ENABLE. Insert \$20 Canadian note to test. Press OK on device tester screen and remember to remove the inserted note(s) from Stacker (Vault).
