Subject: U-Scan NextGen Coin Cup Breaking

There have been reports of the Telequip Coin Dispenser being caught in the U-Scan door and breaking when the operator or service person pulls the door open. This applies to the U-Scan NextGen 2.0 and 2.5 robot units.

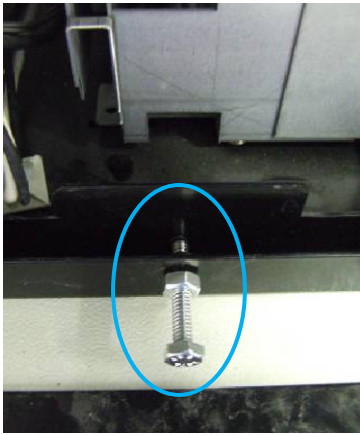
1. Open the Unit
 - Unlock and open the tender bezel of the U-Scan.
 - From the inside of the unit, release the 2 latches and remove the back panel.
2. Replace the broken cup. If the cup is not broken or damaged then skip this step.
 - Pull out the coin dispenser drawer.
 - Replace the damaged cup.
 - 11000878 Left Cup – included in Left Kit
 - 11000879 Right Cup – included in Right Kit
 - The coin cup is attached to the dispenser by a single screw from underneath. Loctite is recommended to prevent the screw from coming loose in the future.
3. Install the Magnetic Bracket
 - Remove the adjustment screw and jam nut at the back of the coin dispenser drawer.

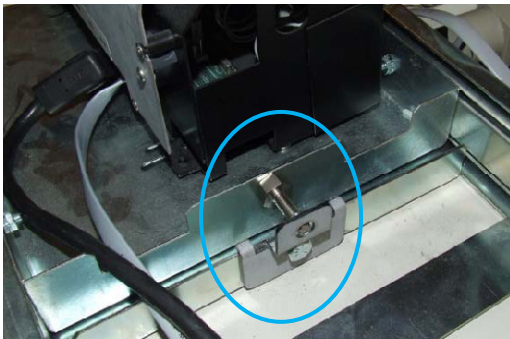
- Attach the new bracket using the included screw. Loctite is recommended to prevent the screw from coming loose in the future.

4. Check and adjust
 - The threaded magnet acts as an adjustment screw to control the depth of the coin dispenser pull-out drawer.
 - Adjust the threaded magnet so it is in contact with the pull-out drawer when retracted.
 - Verify the coin cup is properly positioned within the opening of the tender bezel.
 - Test the new installation by slowly closing and opening the tender bezel door several times.
 - Verify the coin dispenser cut does not jam or get pulled out when the door is opened.
 - When adjustment is completed, tighten the jam nut on the threaded magnet.
 - DONE.
